Fourth Wall Bespoke //  
**BUILDING SURVEY - RICS LEVEL THREE**

*Private Address*

Prepared by: Joshua Weston BSc (Hons) MRICS  
Fourth Wall Building Consultancy

Inspection Date: XX January 2022

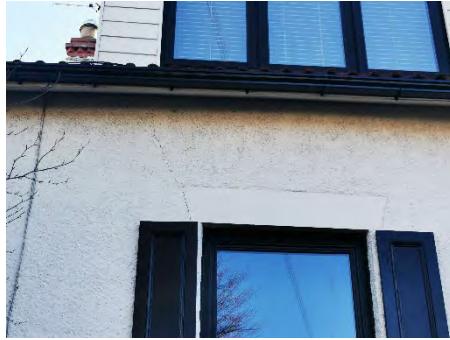
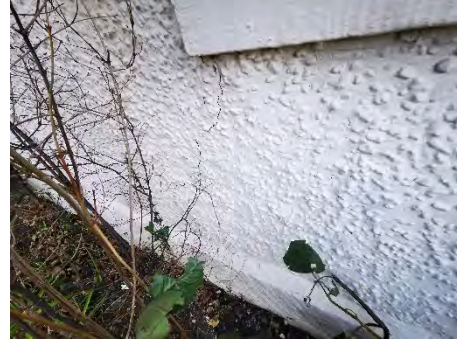
- We noted cracking of approximately 1-2mm vertically to the front and left and gable wall of the property, indicative of rotational movement, potentially caused by an undermining of the foundation by defects to the adjacent below ground drainage, minor settlement of the shallow foundation or a combination of the two.

View of cracking to front elevation.

Where the drainage is found to be in a good condition, further investigation from a structural engineer should be engaged to undertake a full assessment of the property and advice regarding any remedial works required. Further invasive investigation of the building fabric and foundation will likely be required at this stage.

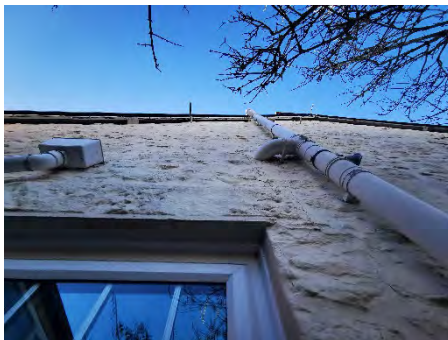
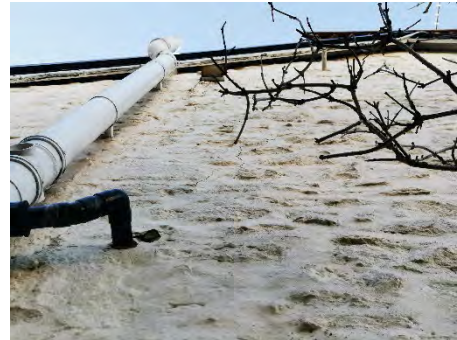
View of cracking to side elevation wall.

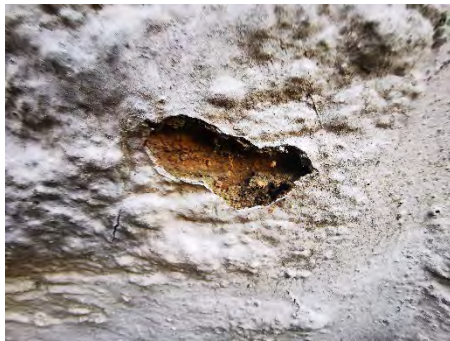
Whilst this does not appear to present an immediate risk to the fabric of the building, as we did not note any evidence of damp related to this issue internally, we recommend that the modern mortar finish is removed and a more sympathetic lime based render is installed within the medium term. All damaged masonry should be removed and replaced, where significant failure has occurred, to prevent future water ingress and further damage to the substrate.

*View of isolated spalling to cementitious render.*

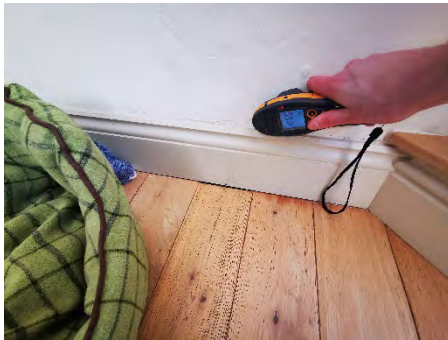
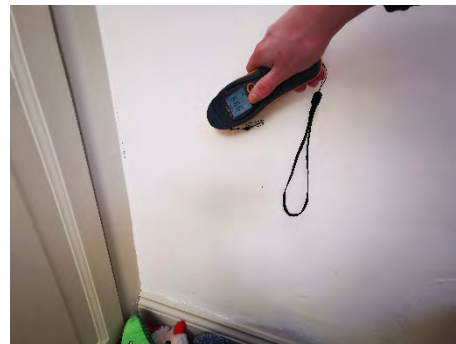
- We noted evidence of damp to the plaster finish to the external wall serving the rear dining room fireplace. Moisture readings were taken which provided elevated readings at the base of the chimney wall. We anticipate this to be due to the use of modern gypsum plaster and continuation of the plaster finish down to the floor slab. This enables moisture to transfer via any assumed Damp Proof Course (DPC) provision within the masonry up the wall, manifesting as discolouration to the decoration. We recommend you budget to remove the plaster finish and reinstate the plaster with lime based alternative at a level above the DPC, typically 150mm from ground level, subject to investigation by the contractor to expose the underlying construction.

*View of moisture reading.*

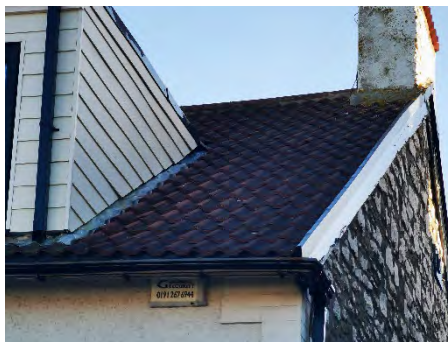
- The covering generally appears to be in a fair condition. We noted lichen build up to the covering. We recommend you budget to clean the roof of any vegetation build up in the immediate term to mitigate against future water ingress.

View of front roof pitch.

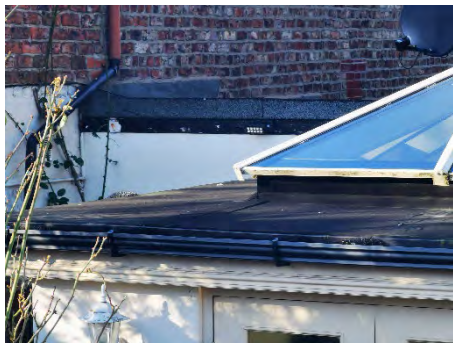
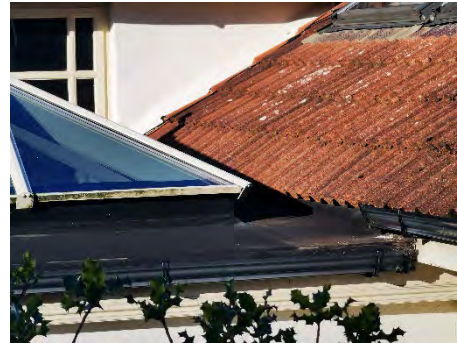
- The roof covering serving the kitchen appears to be in a fair condition. ●

View of flat roof serving kitchen.

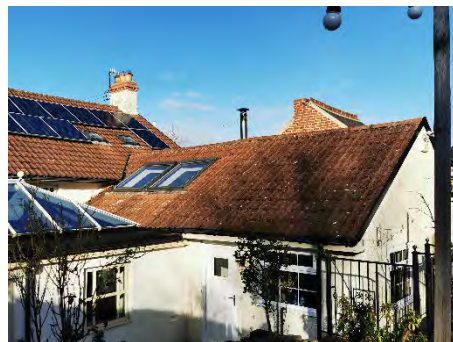
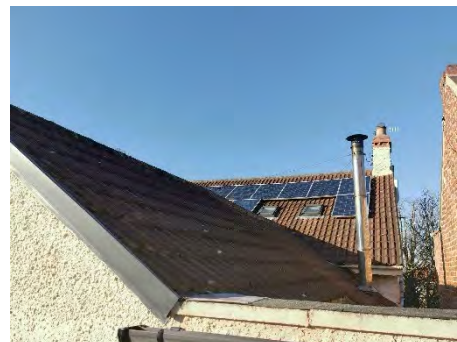
- The pitched roof to rear extension appears to be in a fair condition. ●

View of pitched roof to rear extension.

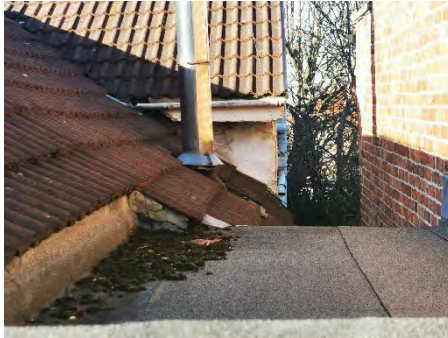
- Whilst we could not view the mineral felt covering to the front and rear dormer roofs, we did not note any visual evidence of water ingress internally to suggest the covering was not performing as intended at the time of our inspection.
- The flat roof covering above the bathroom appears to be in a fair condition with minor debris build-up noted adjacent to the pitched roof covering. We anticipate this is due to a lack of routine maintenance. We recommend you budget to clean down the roof coverings to ensure proper egress of surface water to mitigate against penetrating damp and premature expiry of the covering.

View of flat roof to rear extension.

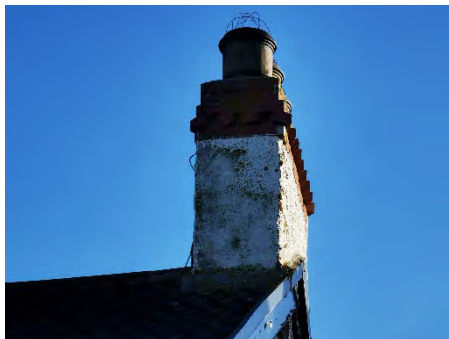
Whilst we did not note evidence of damp internally associated with the render, the render is in a poor condition. We recommend you budget to remove the render and renew with a suitable lime based alternative in the short term to mitigate against future issues.

View of right hand gable wall.

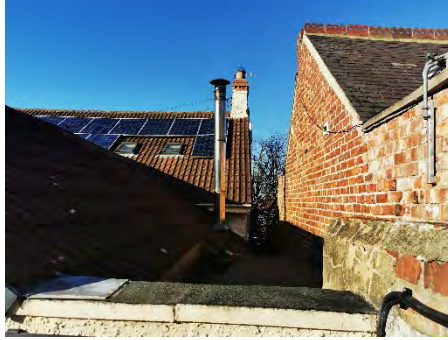
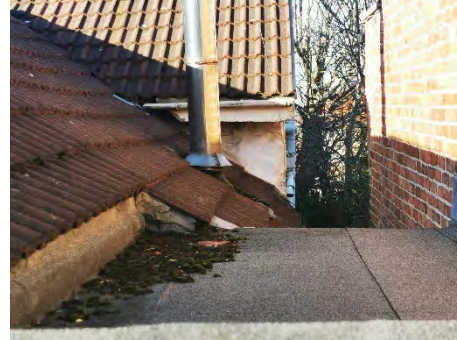
- The flue serving the chimney rear dining room fireplace appears to be in a fair condition.

View of flue to rear dining room fireplace.

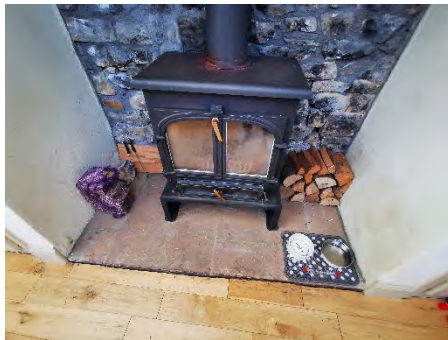
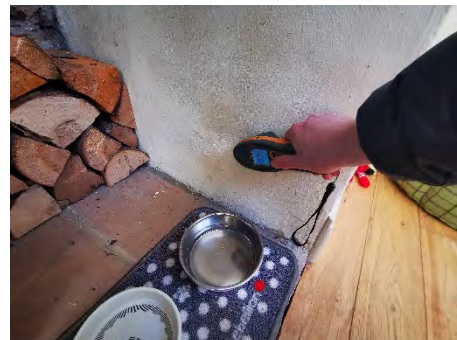
We anticipate this to be due to the use of modern gypsum plaster and continuation of the plaster finish down to the floor slab. This enables moisture to transfer via any assumed DPC provision within the masonry up the wall, manifesting as discolouration to the decoration. We recommend you budget to remove the plaster finish and reinstate with the plaster with lime based alternative at a level above the DPC, typically 150mm from ground level, subject to investigation by the contractor to expose the underlying construction.

View of rear dining room fireplace.

View of moisture meter reading to rear dining room fireplace.

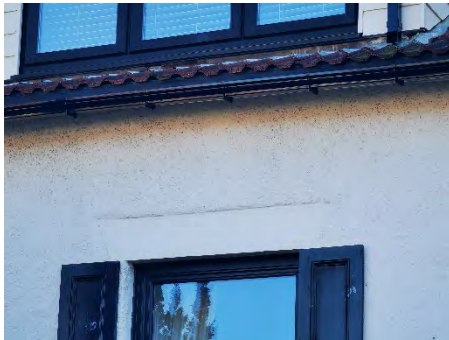
- There were no signs of water staining or runoff below the gutters or overflow weirs to suggest any problems associated with the capacity of the gutters. The gutters and overflow weirs appeared to be in reasonable condition and will provide early warning when the rainwater outlets become blocked or the gutters cannot take the amount of water being discharged into them.

*View of guttering to front roof pitch.*

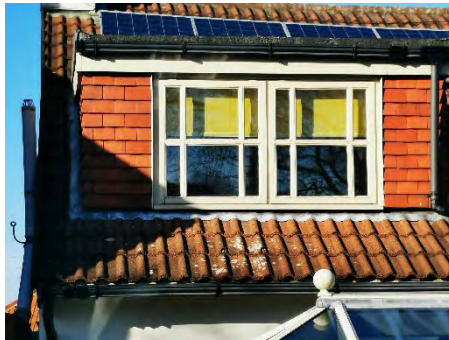
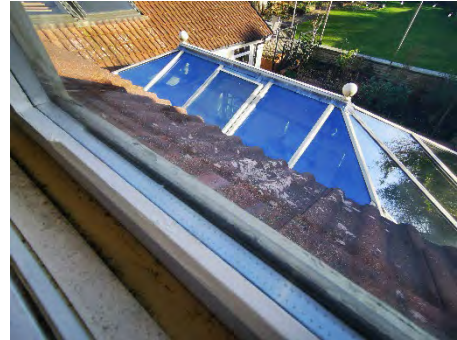
- The decoration to the timber windows exhibits fatigue and will require renewal within the short term to prevent deterioration of the underlying timbers. The timber should be thoroughly prepared and decorated with 1no. coat exterior grade primer and 2no. coats exterior grade paint. ●

View of timber window to rear dormer.

View of fatigue to decoration.

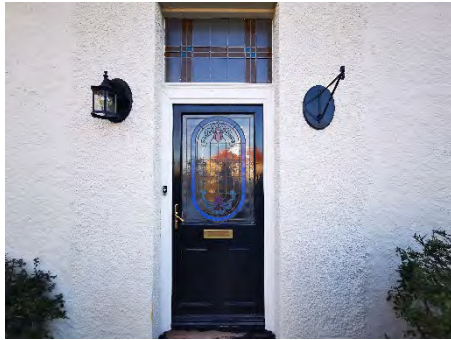
- The doors appear to be in a fair condition. The doors were tested and found to be operable at the time of inspection.

*View of front entrance door.*

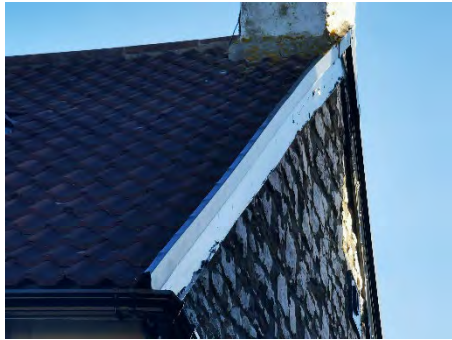
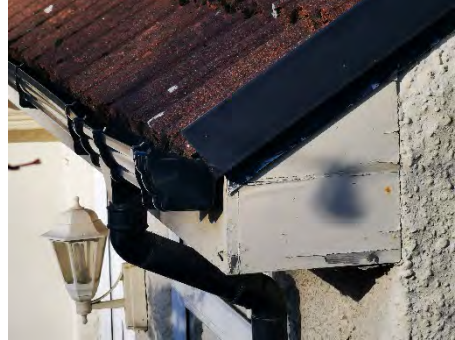
- The decoration to the timber fascia’s, soffits and barge boards generally appears fatigued and will require renewal within the short term to prevent deterioration of the underlying timbers. The timber should be thoroughly prepared and decorated with 1no. coat exterior grade primer and 2no. coats exterior grade paint.

View of fatigued decoration to barge board.

View of fatigued decoration to fascia and soffit.

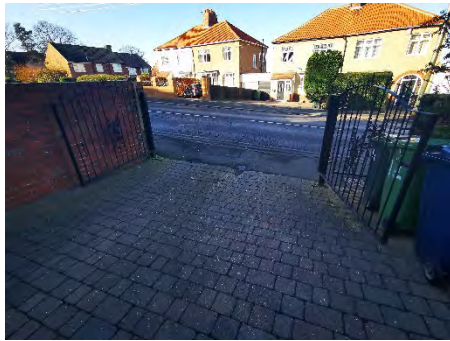
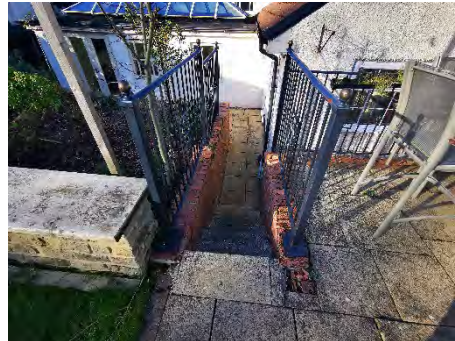
- The decoration to the entrance gates and rear patio balustrade generally appears fatigued and will require renewal within the short term deterioration of the underlying metal. The metal should be thoroughly prepared and decorated with 1no. coat exterior grade primer and 2no. coats exterior grade paint.

View of fatigued decoration to gate.

View of fatigued decoration to rear patio balustrade.

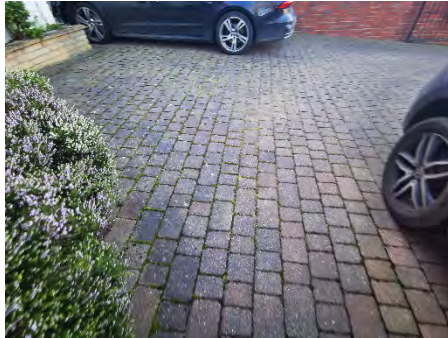
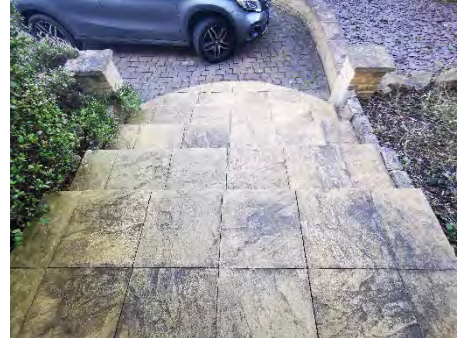
- The covering to the driveway, rear patio and external steps generally appear to be in a fair condition. Undulation was noted to the driveway covering, we anticipate this to be indicative of issues with the below ground drainage, which is within close proximity to this area. Further investigation to confirm the condition of the drainage will be required and isolated repairs to the covering will be required.

View of driveway covering.

View of steps to front entrance.

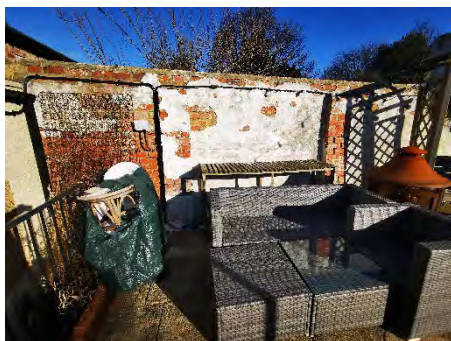
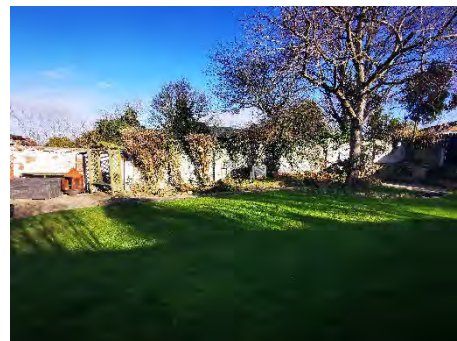
- The decorated finish to the side boundary wall generally appears in a poor condition as is unsuited to the type of brickwork onto which it is installed. We recommend you budget to remove the finish and undertake isolated repairs to the brickwork and underlying pointing. The wall otherwise appears to be in a fair condition.

View of rear wall.

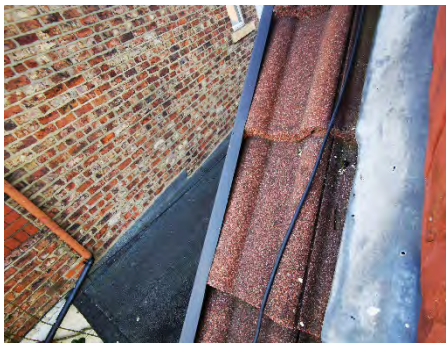
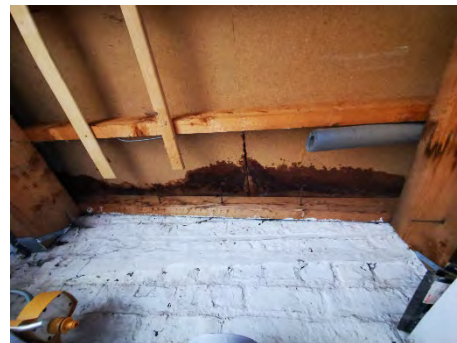
View of flat roof detail to garage.

View of staining to flat roof deck.

We recommend you budget to renew the flashing detail with lead in the immediate term to mitigate against further water ingress. Affected timbers, whilst not structurally compromised, should be treated with a preservative treatment to mitigate against timber decay and further deterioration.

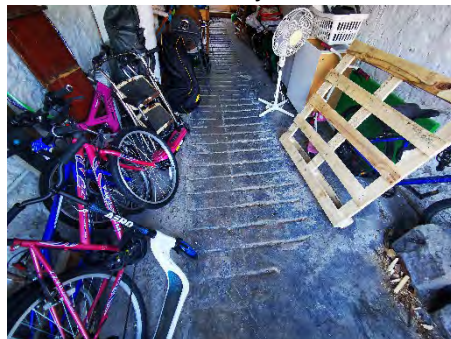
- ▪ We did not note signs of significant moisture ingress to the extension or garage floors. Minor moisture staining was noted to the garage floor, which we anticipate is due to the age and type of construction and apparent use of the space. The levels of moisture noted appear to be suitable for the garages current use for storage on non-perishable items. It may be necessary to engage a structural waterproofing specialist to specify waterproofing treatments should you wish to change the use of the garage.

View of garage floor.

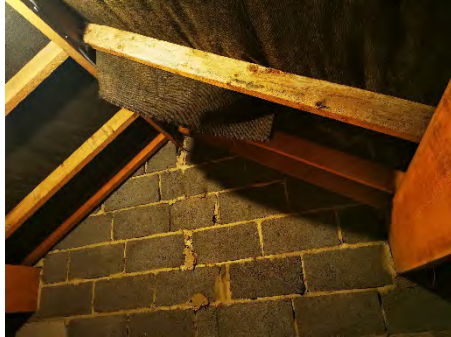
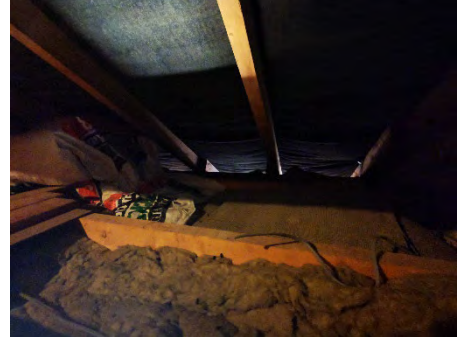
- We noted failure of the roofing underlay serving the extension roof to isolated areas. Whilst this does not appear to be causing issues in the immediate term, we recommend you budget to undertake isolated repairs to mitigate against water ingress. This will involve cutting back the loose section of felt and installation of a patch repair using modern permeable underlay.

View of loose section of underlay.

View of underlay to secondary roof.

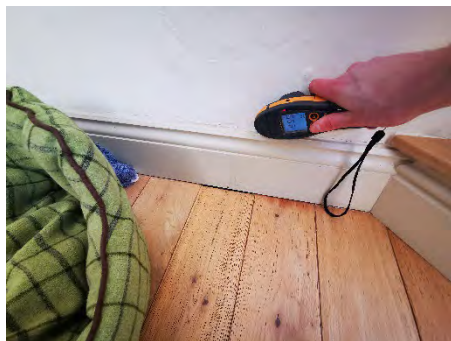
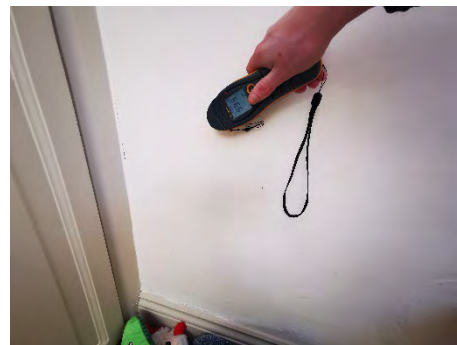
- We noted evidence of damp to the plaster finish to the internal wall serving the rear dining room and utility room. Moisture readings were taken which provided elevated readings at the base wall. We anticipate this to be due to the use of gypsum plaster and continuation of the plaster finish down to the floor slab and differential floor levels between the two rooms. This enables moisture to transfer via any assumed DPC provision within the masonry up the wall, manifesting as discolouration to the decoration. We recommend you budget to remove the plaster finish and reinstate the plaster with waterproofing membrane onto which plaster skim can be applied, subject to investigation by the contractor to expose the underlying construction.

*View of moisture reading.*

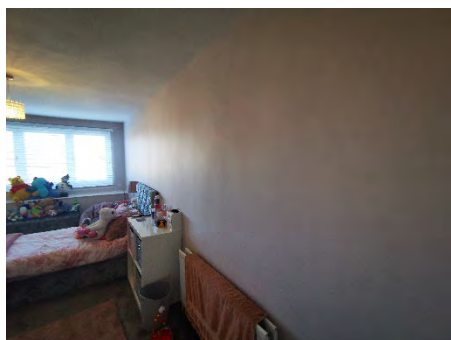
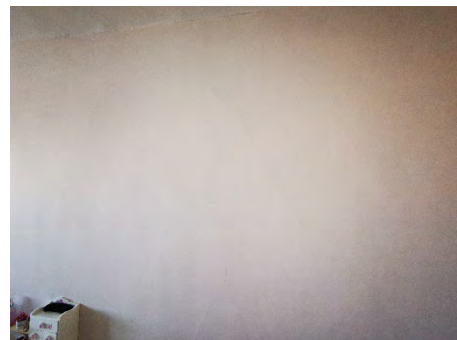
- We noted hairline cracks to the internal spine walls within the first floor middle bedroom. We anticipate this is due to a combination of shrinkage caused by drying out of the materials following construction and minor historic movement of the structure. Superficial repairs will be required prior to redecoration.

*View of hairline cracking to bedroom wall.*

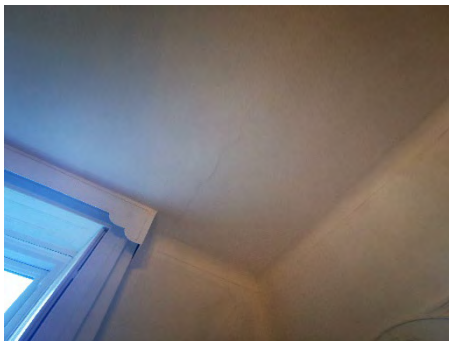
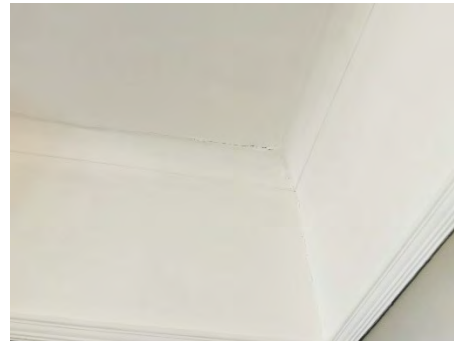
- The lath and plaster ceilings are in a fair condition given the property's age. However we noted several hairline cracks to the ceilings generally, particularly to the front reception room, which we anticipate may be related to movement of the main walls to the property noted externally. There were no notable signs of bounce or excessive sagging to the ceilings, therefore we do not anticipate any immediate remedial works required to plaster finish, beyond superficial repairs will be required prior to redecoration. ●

*View of hairline cracking to front reception room.*

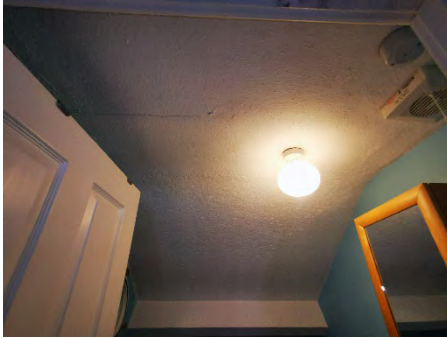
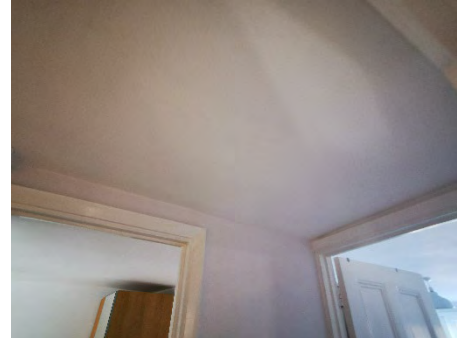
- We noted isolated hairline cracks along plasterboard joints throughout the property. We anticipate this is due to shrinkage caused by drying out of the materials following construction. Superficial repairs will be required prior to redecoration.

*View of hairline cracking to first floor toilet.*

*View of hairline cracking to landing ceiling.*

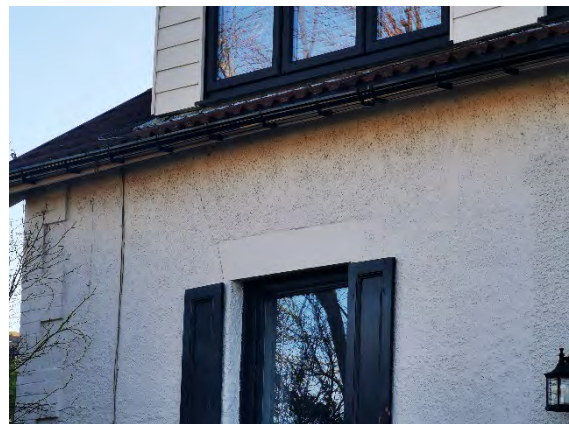
4. Cracking above window.
