Fourth Wall Bespoke // HOME SURVEY - RICS LEVEL TWO

Of the premises known as //
Private Address

Inspection Date: XX March 2022

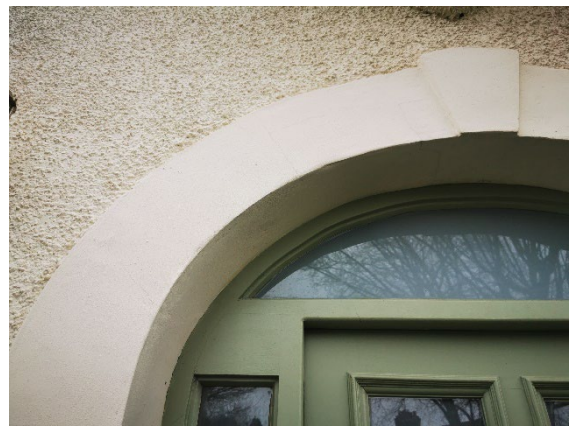
- The brickwork generally appears to be in a fair condition. ●
- The render generally appears to be in a fair condition with isolated damage noted to the rear dormer finish and hairline cracking noted above the front entrance door aperture. We anticipate the hairline cracking noted above the front door detail is due to fatigue to the finish and subsequent water ingress behind the finishing coat. We recommend you budget to undertake repairs within the short term to mitigate against further deterioration. ●

4. Hairline cracking to render finish.

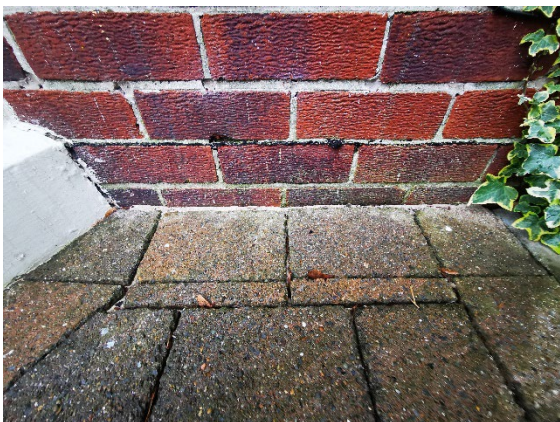
The presence of a DPC is typically obscured by mortar pointing and render finishes externally and plaster finishes internally. However, we did note the presence of a physical DPC exposed at regular intervals to the external brickwork, which would suggest a DPC was installed at the time of construction. Although it should be noted we cannot definitively conclude the presence of a DPC to the entirety of the structure without undertaking invasive investigation.

5. Suspected DPC to front elevation.

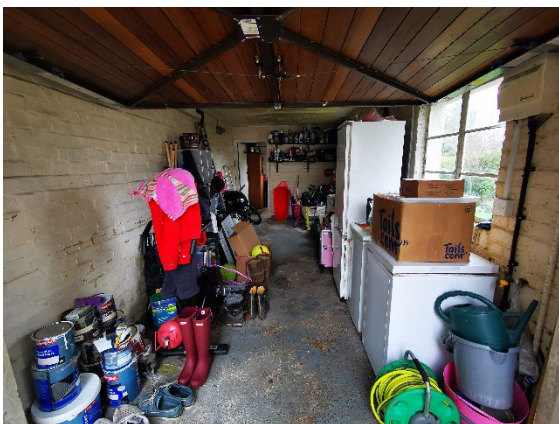
17. View of garage internally.

- The garage doors appear to be in a fair condition. ●
- We noted extensive deterioration of paint finishes to the garage walls internally. This is likely due to a combination of either a bridge of the Damp Proof Course (DPC) due to the elevated ground levels or via the render finish externally, a lack of DPC provision, use of a non-permeable paint internally or a combination. Extensive repairs will be required in the short term to mitigate against further issues. ●

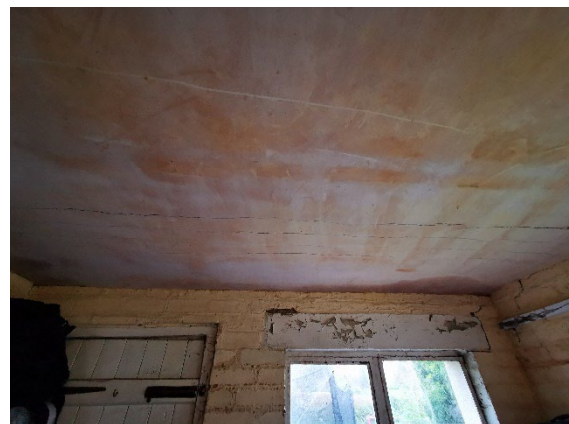
- We noted spalling concrete and evidence of corrosion to the metal reinforcement of the concrete slab serving the garage flat roof. We anticipate this is due to a combination of latent defects to the slab at construction and potential historic water ingress. Additionally, expansion caused by the metal corrosion has caused lateral movement to the external walls of the garage. Extensive repairs to the roof and walls will be required to stabilise the deterioration of the structure in the short to medium term. However, wholesale replacement may prove to be a more cost effective solution. ●

18. View of cracking to garage roof. Note cracking to external walls.
