Fourth Wall Bespoke // BUILDING SURVEY - RICS LEVEL THREE

Of the premises known as //
Private Address

Prepared by: Joshua Weston BSc (Hons)MRICS
Fourth Wall Building Consultancy
Telephone: +44 (0)161 706 1131
Email: joshua.weston@fourthwallbc.com
Inspection Date: 6th September 2022
Report Issue Date: 9th September 2022

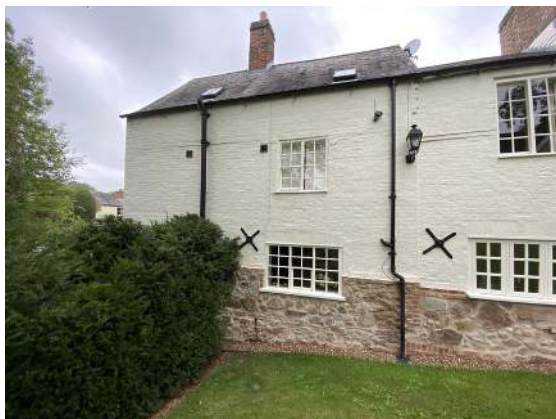
- We noted wall plates located to the external walls of the property, namely the front and rear. This suggests that the building experienced lateral movement historically and we anticipate the wall plates were installed retrospectively as a remedial measure.

Wall plate installation

We recommend your solicitors request further details of structural remedial works, including any reports or assessments undertaken to determine the remedial measures undertaken are appropriate. Measures of this nature should typically be specified and in some cases monitored by a Structural Engineer to ensure their adequacy. Where no documentation is available, there will be limited redress in the event latent defects become apparent.

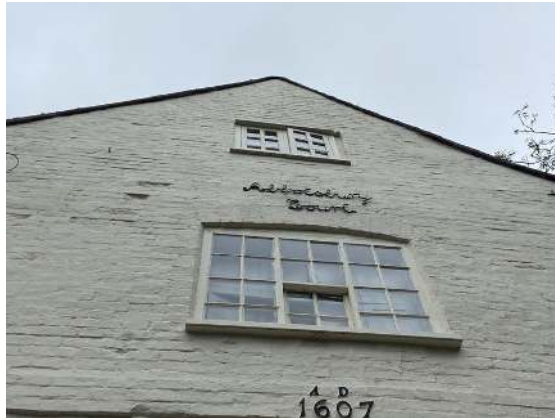
Additionally, we noted a bulge to the side elevation external wall below the window serving the upper floor bedroom. However, this appears to be historic with repair work noted and no evidence of subsequent cracking to suggest this movement is progressive.

Bowing noted to side elevation

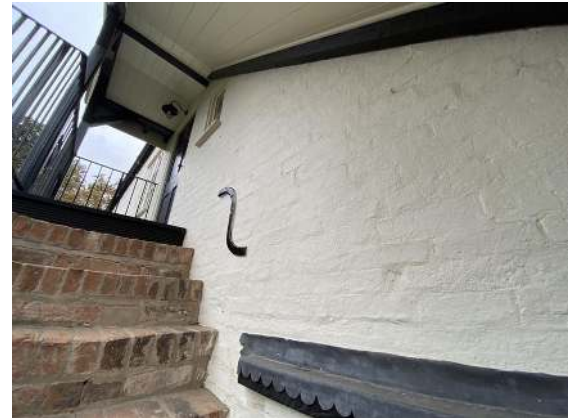
Wall plate installation

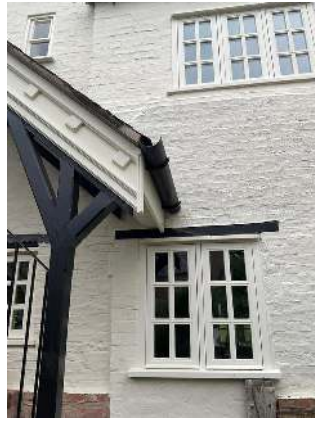
- The roof which serves the external front steps has a gutter located at the base of arrangement. The gutter is not provided with a downpipe and therefore does not have an effective way to remove the rainwater from the external fabric. We recommend a downpipe is installed to drain the water directly into an underground drain arrangement to ensure rainwater is being disposed of effectively.

Gutter with no downpipe

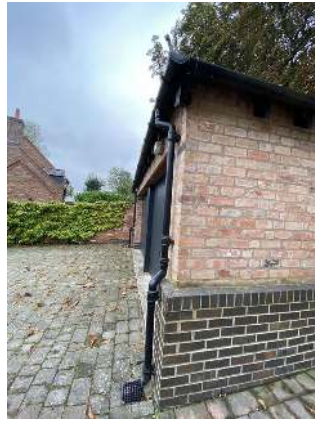
- We noted evidence of minor undulation to paver covering to driveway adjacent to garage doors. We anticipate this to be caused primarily by the imposed load of vehicle traffic due to deficiencies in the quality of the sub-base to the covering. However, given the apparent proximity of surface water drainage, it would be prudent to arrange for a CCTV drainage survey to confirm the condition of the drainage system in order to discount the possibility of underlying issues which may not be immediately apparent. ●

Driveway covering undulation noted

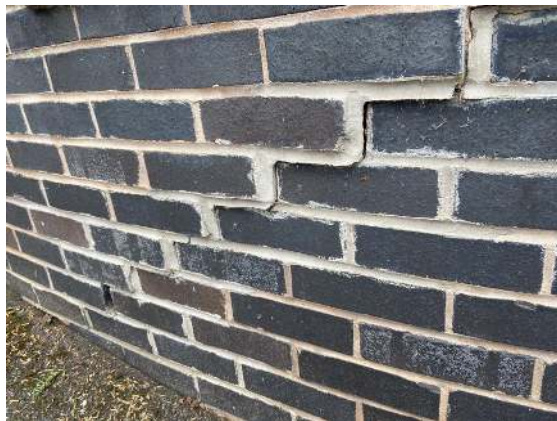
(iv)	The boundary wall exhibits signs of lateral movement at the mid-section. This appears to have been repointed which has since reopened, which would suggest movement is progressive. We anticipate the movement has occurred due to the curved form of the wall, which may have been aggravated by the close proximity of boarder plants. Given the age of the wall and its condition, we do not believe this presents an immediate threat of collapse. However, we recommend you budget to have helibar ties installed to provide additional support to the structure and engage an arboriculturist to advise regarding the management of adjacent privet to mitigate against further movement.	Purchaser	●

Boundary wall movement

Given the age of the wall and its condition, we do not believe this presents an immediate threat of collapse. However, we recommend you budget to have helibar ties installed to provide additional support to the structure and engage an arboriculturist to advise regarding the management of adjacent privet to mitigate against further movement.

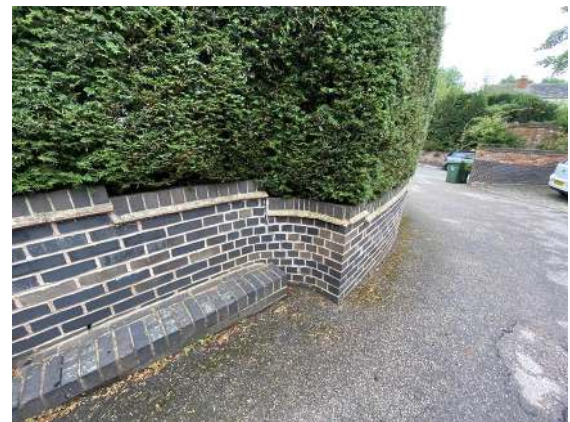
Boundary wall movement

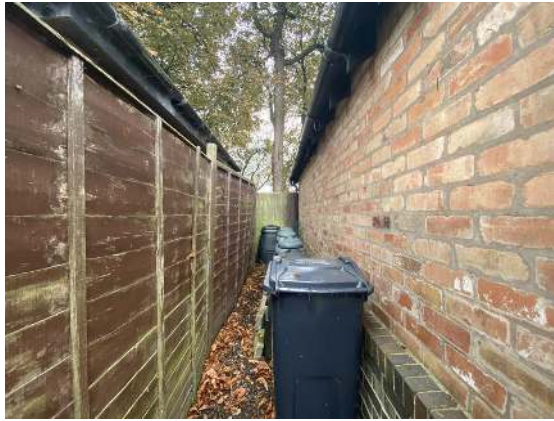
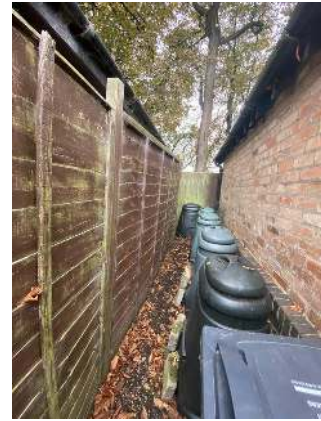
- The decoration to the fence panels adjacent to the bin store generally appears fatigued and will require renewal within the short term deterioration of the timber. The timber should be thoroughly prepared and decorated with 1no. coat exterior grade primer and 2no. coats exterior grade paint. ●

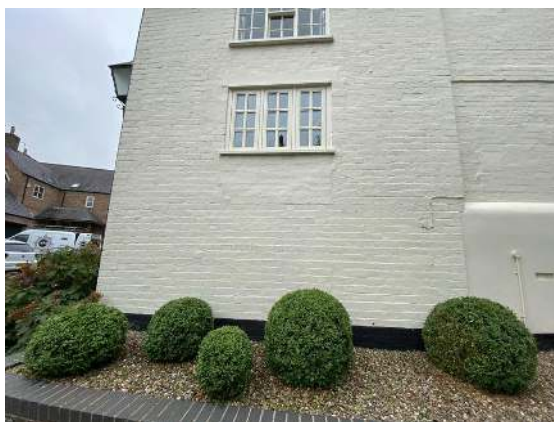
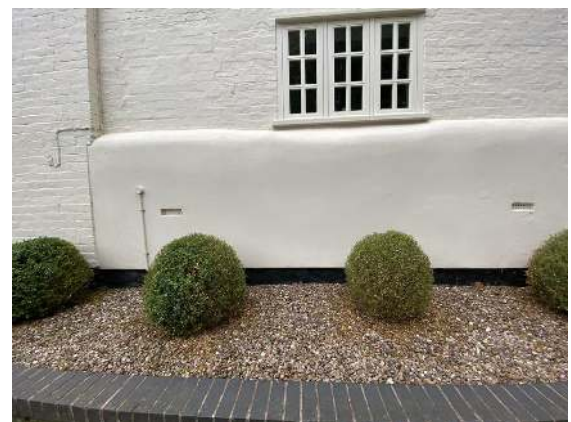
- We noted vents to the Swan Street elevation appear partially blocked with paint, limiting ventilation to the sub-floor void and adjoining basement. We recommend you budget to clear all air bricks of debris to ensure adequate ventilation to mitigate against decay to timber elements. ●

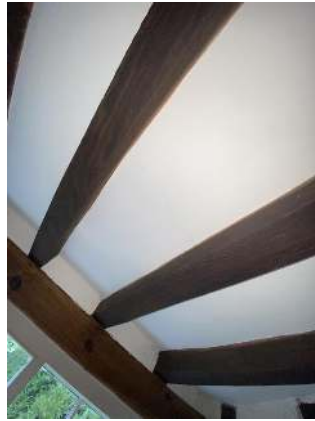
- We noted isolated hairline cracks along plasterboard joints throughout the property. We anticipate this is due to shrinkage caused by drying out of the materials following construction. Superficial repairs will be required prior to redecoration. ●

Shrinkage crack noted

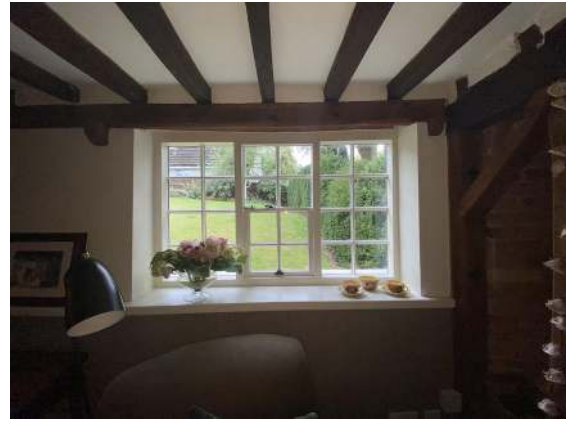
Ceiling affected by shrinkage

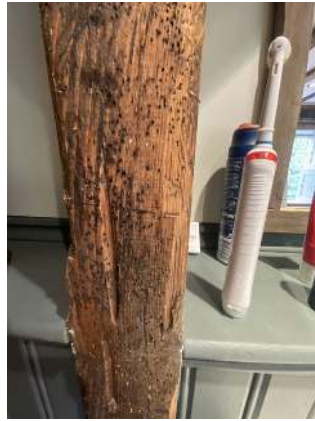
- We noted evidence of active woodboring beetle to internal joinery, specifically to the timber cladding adjoining the coal shoot to the cellar, which appears localised and does not appear to have spread to structural timber elements, such as the floor joists. Further specialist treatment to mitigate against further spread and deterioration of fabric will be required in the immediate term. We recommend your solicitor request details regarding any historic treatment of wood boring insects and any related warranties or guarantees which may be available to transfer to the purchaser upon completion of the sale. ●

Evidence of wood boring beetle within first floor bathroom

- (i) We recommend a CCTV drainage survey is undertaken to confirm the condition of the below ground drainage.
- (ii) Further investigation and assessment of suspected wood boring beetle infestation to basement internal joinery by specialist to advise regarding treatment and confirm scope of infestation.

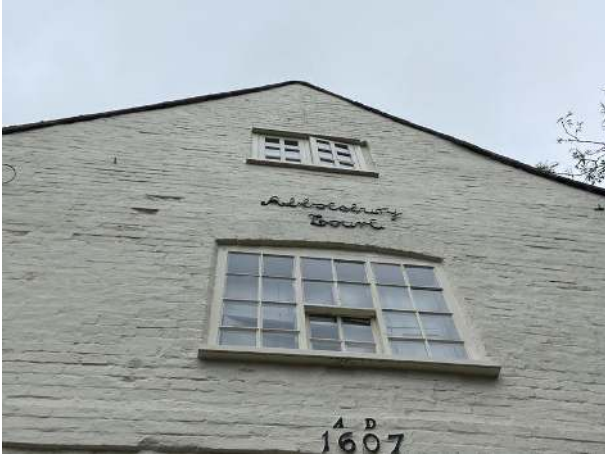
7. Bowing noted to side elevation

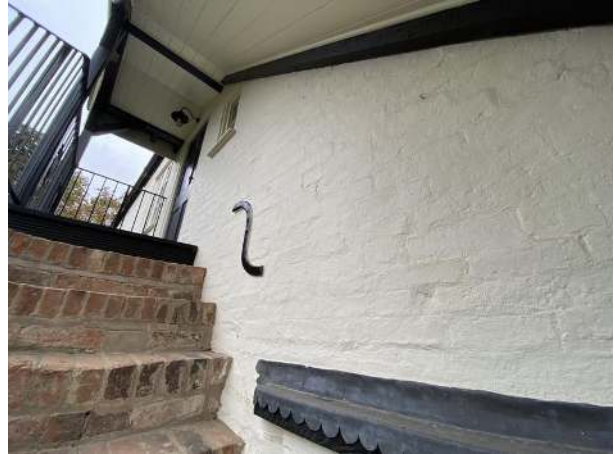
8. Wall plate installation

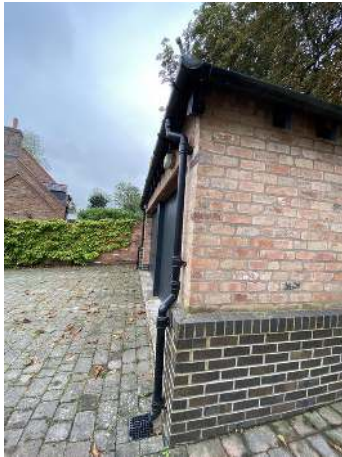
39. Driveway covering undulation noted

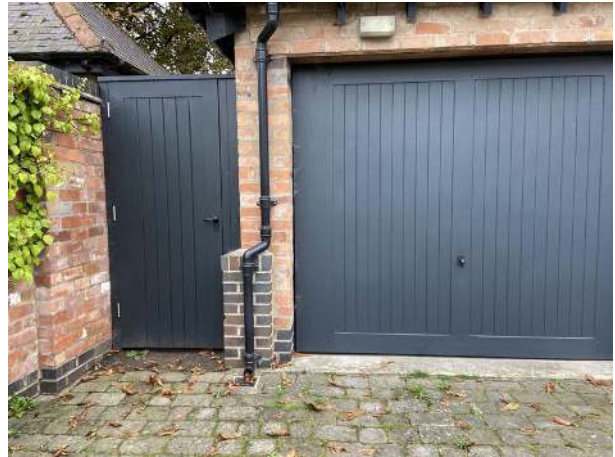
40. Driveway covering undulation noted

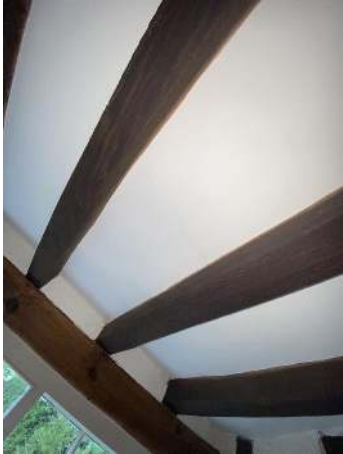
73. Shrinkage crack noted

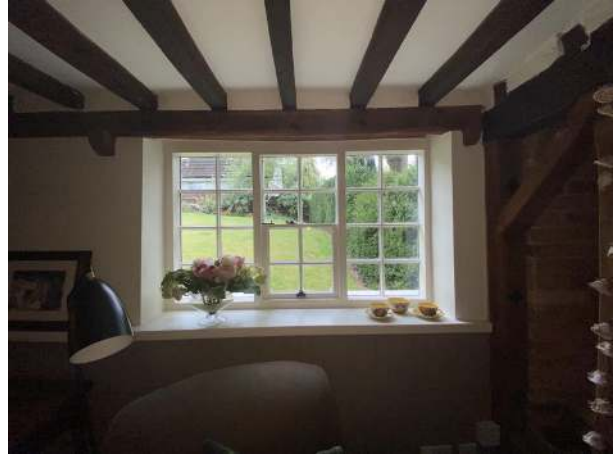
74. Ceiling affected by shrinkage
