## Fourth Wall Bespoke // SNAGGING SURVEY

Of the premises known as //  
*Private Address*

Prepared by: Joshua Weston BSc (Hons) MRICS  
Fourth Wall Building Consultancy

Inspection Date: XX March 2022

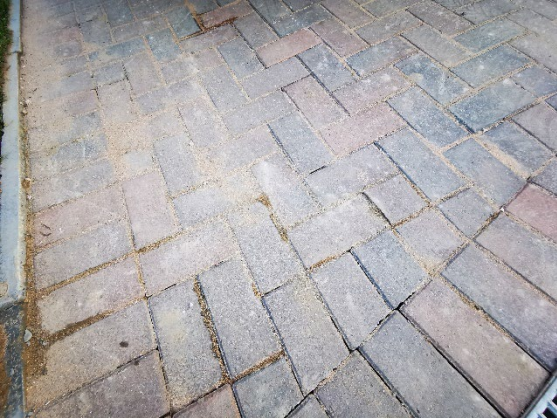
Item	Description	Rating	Image
4.1.	<p>Brick pavers undulated to driveway. Loose pavers noted to isolated areas.</p> <p>Allow to lift and relay with suitable sub-base.</p>	●

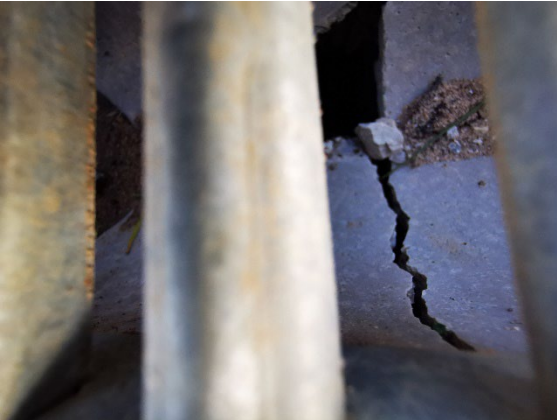
4.2.	<p>Surface water drainage not adequately connected to drainage system. Adhoc inlet created. Cracking noted to drain.</p> <p>Allow to replace damaged section.</p>	●

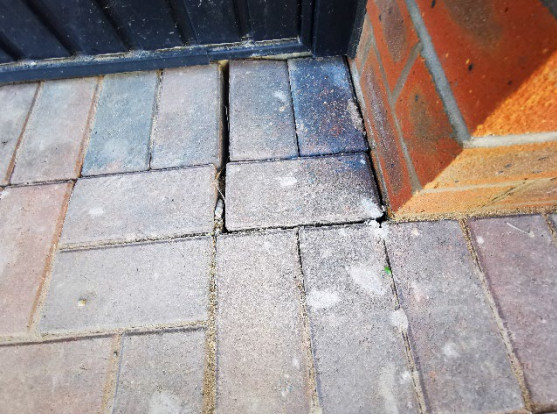
4.3.	<p>Brick pavers undulated to driveway. Loose pavers noted to isolated areas.</p> <p>Allow to lift and relay with suitable sub-base and jointing compound.</p>	●

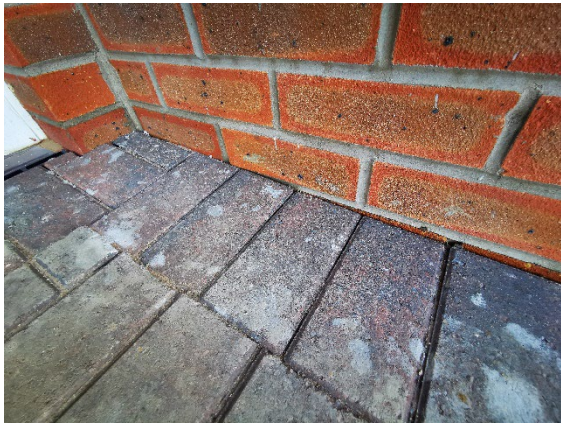
Item	Description	Rating	Image
4.4.	<p>Paving laid within close proximity to Damp Proof Course (DPC).</p> <p>Allow to relay to appropriate level to comply with regulations/ set back with surface water drainage channel.</p>	●

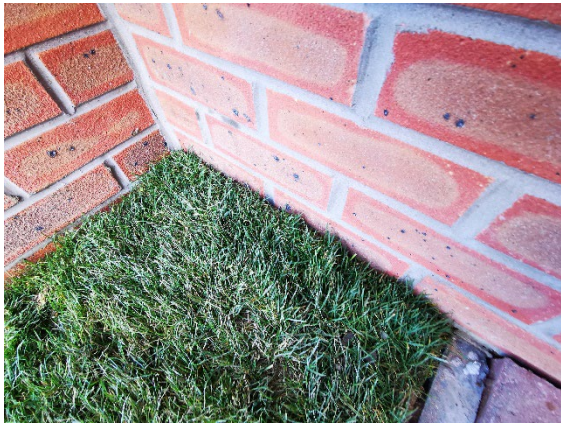
4.5.	<p>Finished ground level and turf covering laid within close proximity to Damp Proof Course (DPC).</p> <p>Allow to relay to appropriate level to comply with regulations.</p>	●

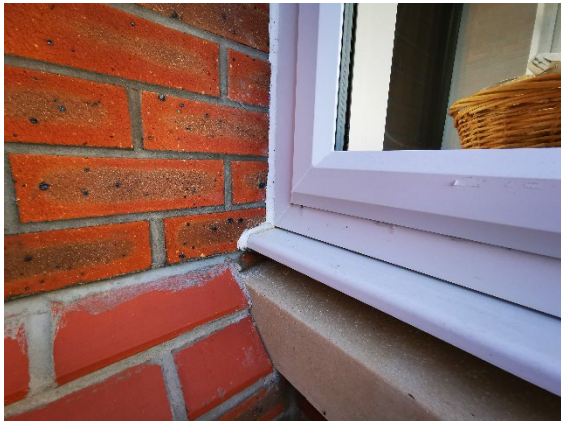
4.6.	<p>Pointing missing at front elevation sill detail.</p>	●

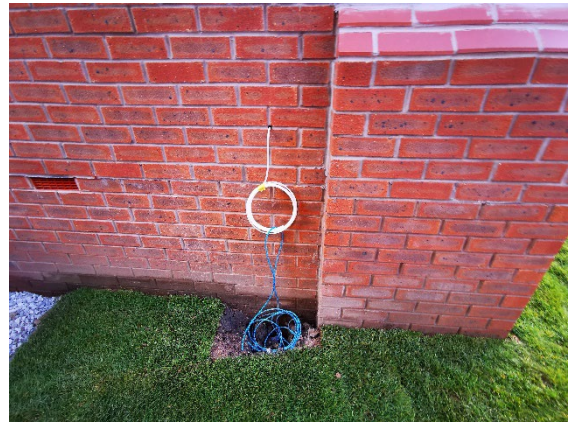
**4.7.** Wiring untidy.

Allow to complete and instate landscaping finishes.

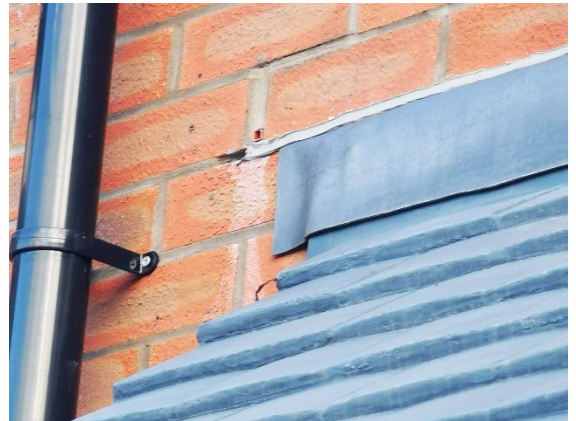
**4.8.** Missing section of pointing to lead flashing details.

Allow to complete.

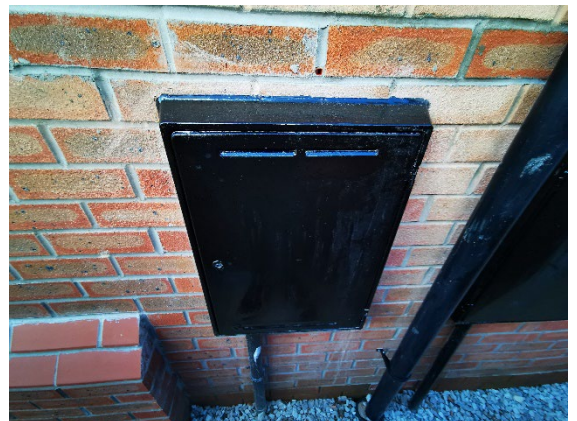
**4.9.** Door to electrical supply cabinet warped and does not close properly. Door mechanism to gas meter cabinet damaged not operable.

Allow to replace and leave in working order.

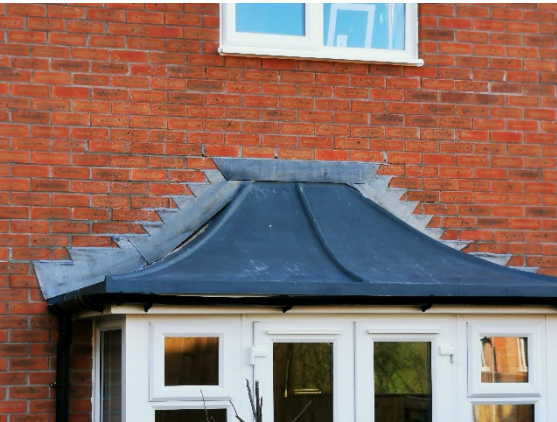
Item	Description	Rating	Image
4.10.	<p>Missing section of pointing to lead flashing details.</p> <p>Debris noted to the covering. Allow to clean down.</p>	●

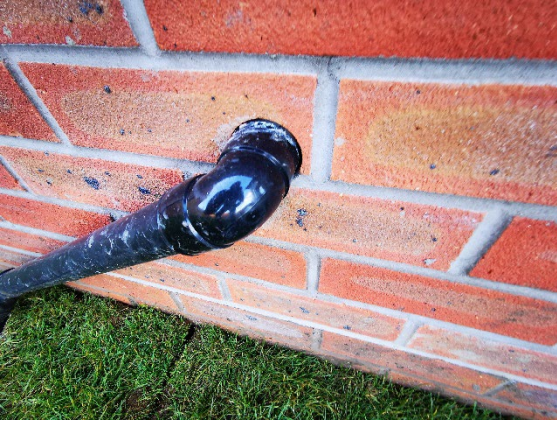
4.11.	<p>Sealant missing to pipework aperture.</p> <p>Allow to apply suitable external sealant.</p>	●

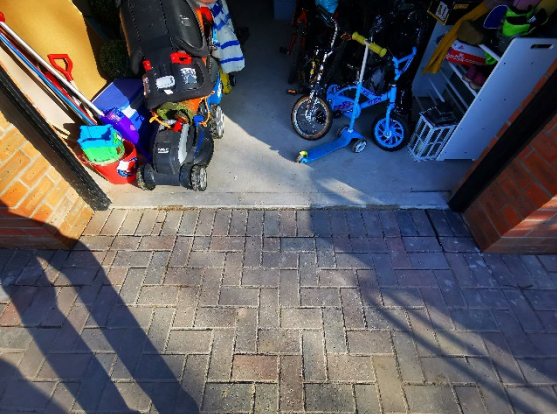
4.12.	<p>No surface water drainage channel provided to garage entrance to prevent ingress.</p> <p>Allow to lift covering, install aco drainage, connect to drainage system and reinstate covering.</p>	●

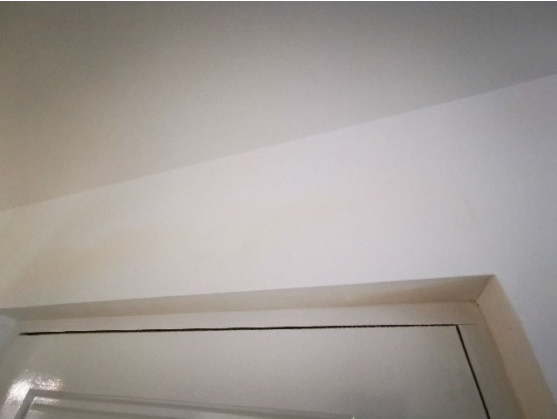
Item	Description	Rating	Image
5.1.	<p>Staining noted above door openings.</p> <p>Allow to redecorate.</p>	●

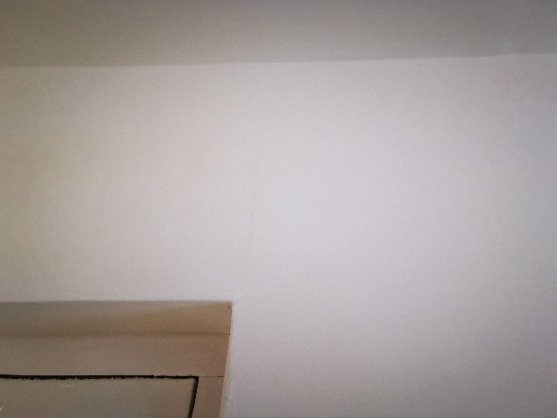
5.2.	<p>Hairline cracking noted to plasterwork at board joints.</p> <p>Allow to fill, prepare and redecorate.</p>	●

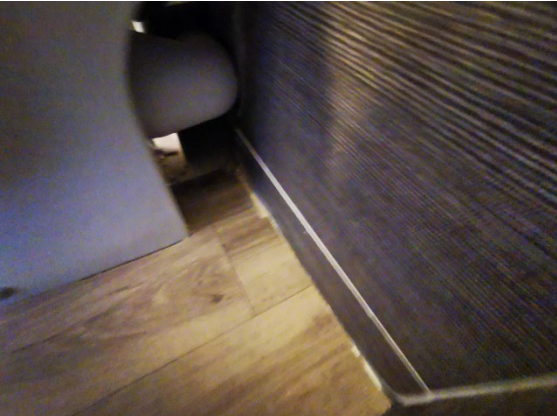
5.3.	<p>Sealant missing to tiling finishes to toilet and around sanitaryware.</p> <p>Allow to apply suitable sealant.</p>	●

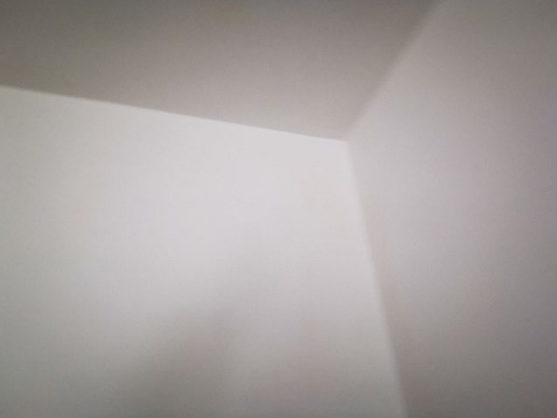
Item	Description	Rating	Image
5.4.	Staining noted above door openings.  Allow to redecorate to satisfaction of owner.	●

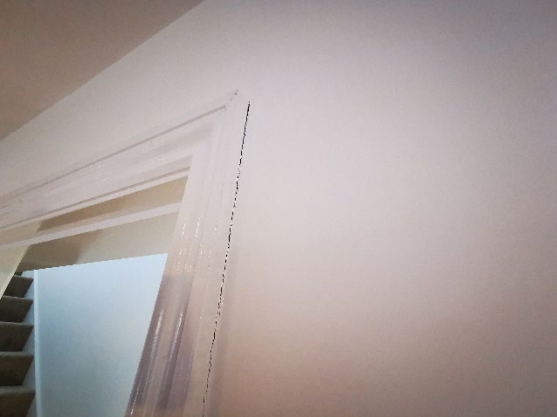
5.5.	Hairline cracking at architrave detail to doors generally.  Allow to seal with flexible caulk.	●

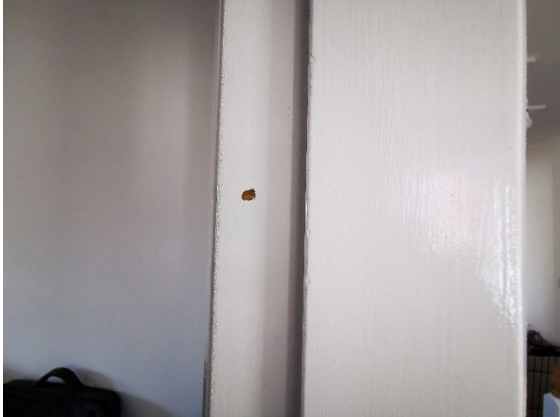
Item	Description	Rating	Image
5.7.	Damaged not to decoration to door frames and finishes generally.  Allow to decorate and make good to satisfaction of owner.	●

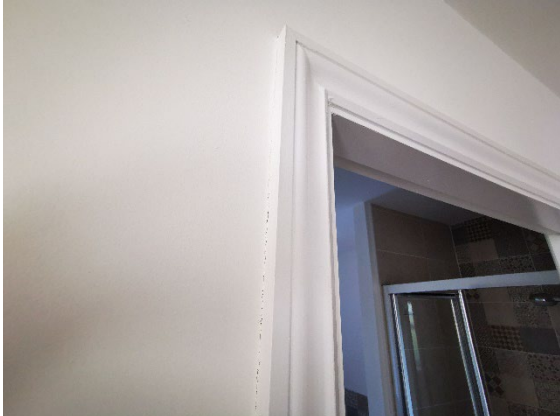
5.8.	Hairline cracking at architrave detail to doors generally.  Allow to seal with flexible caulk.	●

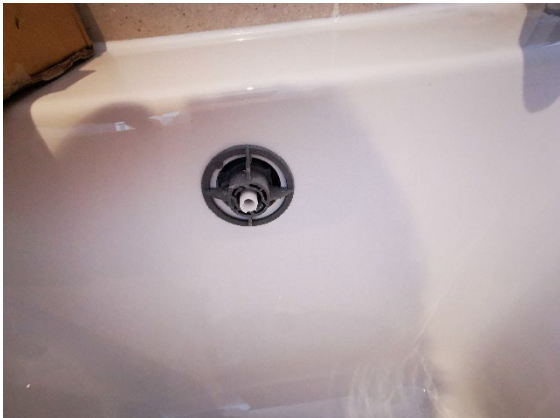
5.9.	Plug mechanism and finishes not provided to first floor bathroom.  Allow to install.	●

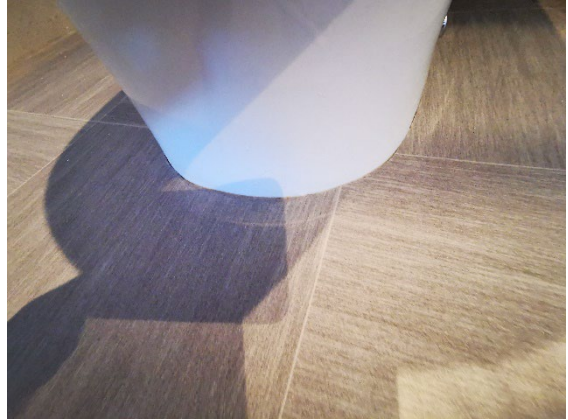
Item	Description	Rating	Image
5.10.	Sealant missing to tiling finishes to toilet and around sanitaryware.  Allow to apply suitable sealant.	●

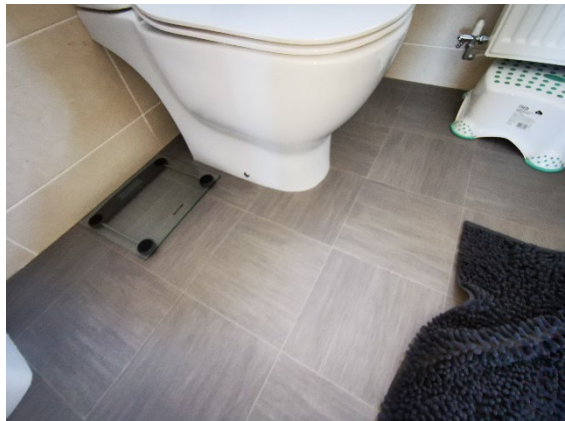
5.11.	Sealant missing to tiling finishes to toilet and around sanitaryware.  Allow to apply suitable sealant.	●
