Private Client
Private Address

July 2021

20.XXX // Specific Defect Inspection: Cracking to two storey external wall and damp to first floor bedroom ceiling

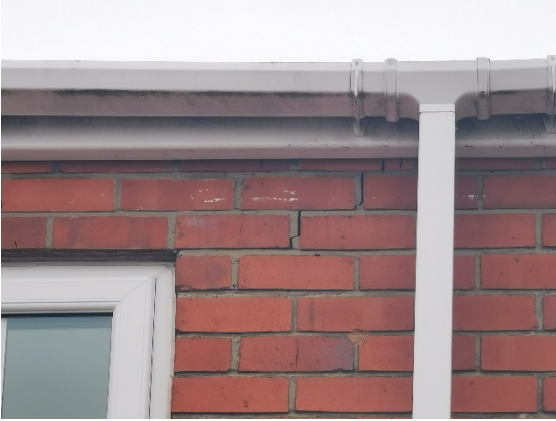
We noted stepped cracking, approximately 1-2mm in diameter at the top right and left hand corner of the first floor window aperture to the external wall. The direction of the cracking would suggest differential rotational movement has occurred to the front elevation.

Brickwork to front elevation first floor window.

Due to the apparent close proximity of the drainage to the foundation of the property, we anticipate the movement to be due to a failure of the drainage, causing erosion of the soil supporting the foundation over a prolonged period causing localised subsidence.

Based on our observations, minor localised structural movement appears to have occurred to the front corner of the two storey extension to the property. We recommend that a CCTV survey is undertaken to confirm the condition and location of the below ground drainage and advise on any remedial works required. At this stage, we anticipate the movement noted to be relatively minor and is likely to be stabilised following repairs to the drainage system. Minor repointing of the external brickwork will be required following remedial works.

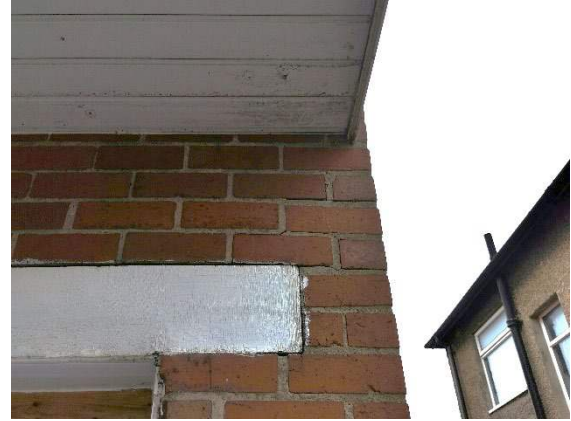
View of brickwork to front elevation garage lintel.

Additionally, we noted stepped cracking of a similar nature to the top right hand corner of the garage door aperture and corresponding hairline stepped cracking to the side elevation origination from the ground floor side elevation window serving the garage. The size and direction of the cracking indicates that rotational movement of the property is generally localised to the front corner of the two storey extension.

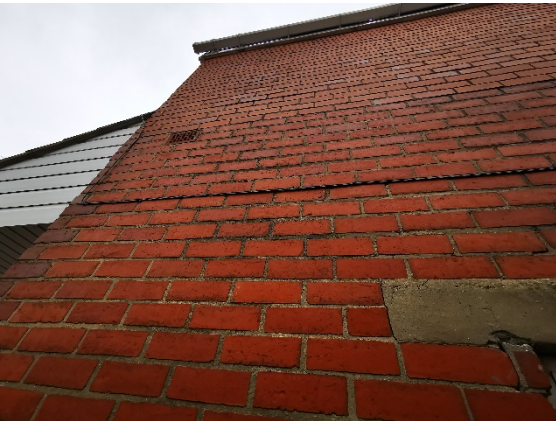
View of cracking to side elevation window.

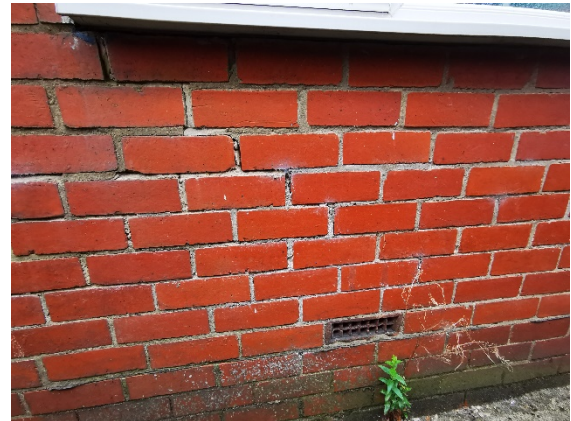
View of stepped cracking below side elevation window.

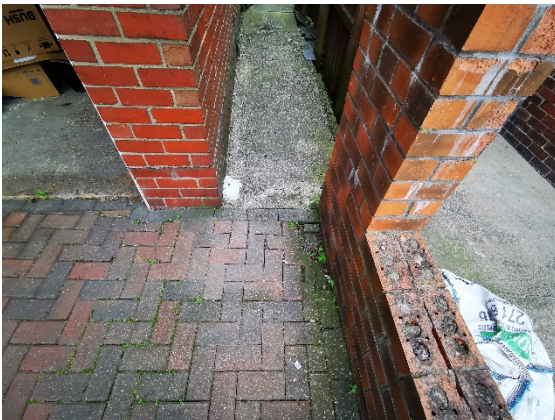
View of defected coverings to external pathway.

Additionally, we noted cracking to the concrete screed to the side path and undulation to the brick paver covering within close proximity to the front corner of the side extension, indicating issues with the below ground drainage.

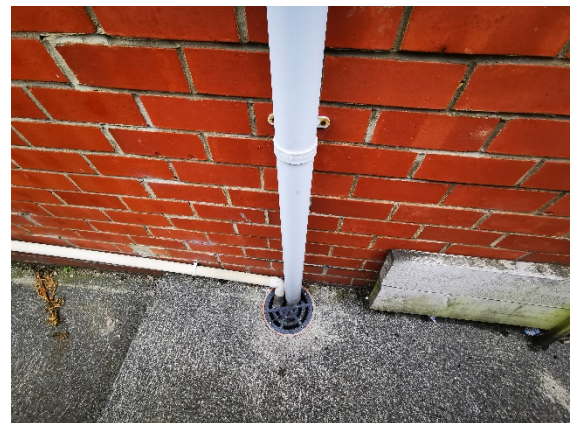
We noted surface water drainage inlets and inspection chamber to the pathway bounding the side elevation. Whilst we are not able to confirm the location of the property drainage, we would assume the below ground drainage runs along the side of the property to the public sewer located below the public highway, as is conventional for properties of this type and age.

View of drainage inlet to side elevation.

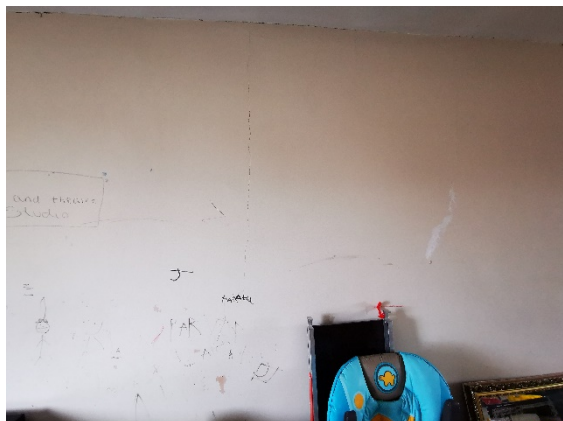
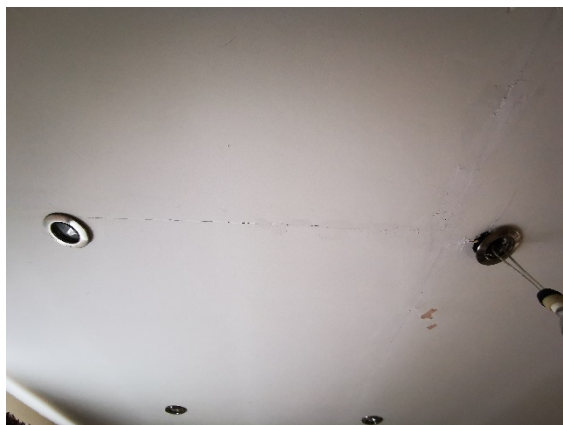
View of cracking internally to plasterwork.

Internally the first floor rooms are finished with a painted plaster skim. The plaster exhibits hairline cracking to the internal walls and ceiling to the first floor bedroom. The majority of the cracking noted appears to be crazed in pattern, which would suggest this is due to poor workmanship upon installation.

There are several hairline cracks which appear to largely follow board joints, which are likely caused by a combination of localised movement noted above and poor workmanship/ shrinkage following construction. Several cracks appear to have been filled with a repair compound, which appears intact, which would suggest any movement historically is no longer progressive. We therefore anticipate only superficial repairs will be required prior to redecoration.

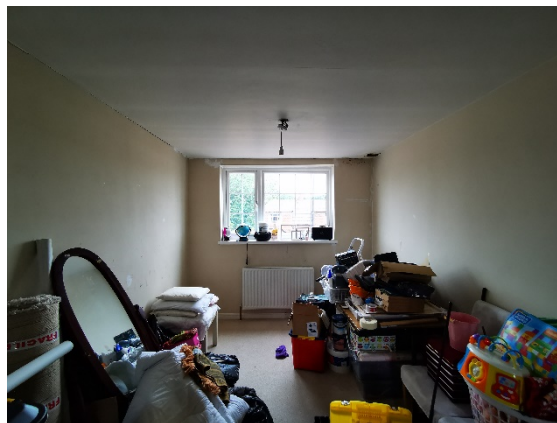
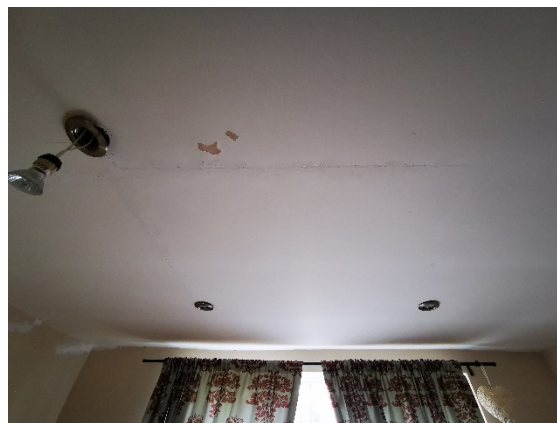
View of plasterwork to first floor.

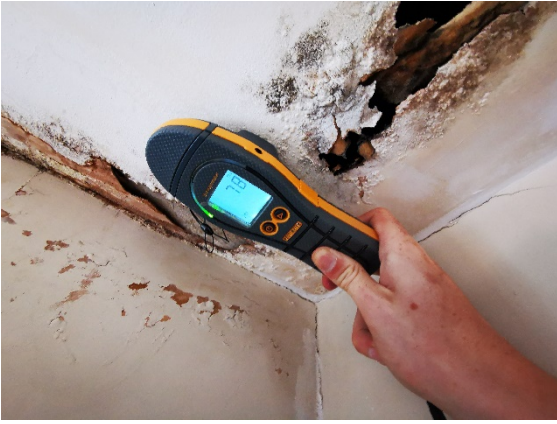
We noted staining and deterioration of the plaster finish to the ceiling within the first floor bedroom adjacent to the front wall. This appears to have been caused by a prolonged leak to the flat roof covering above. The roof void was partially accessible via the damaged plasterwork aperture, and we did not note any signs of significant damage or rot to the timber joists or roof deck.

The plasterwork generally appears dry. Moisture meter readings were taken of the area which corroborated this assessment. We therefore anticipate the damage to be caused by a historic leak which has since been remedied.

View of damage to plasterwork.

We recommend damaged plasterwork to the first floor ceiling is cut away and all timber elements to the flat roof substructure are treated with a preservative treatment to mitigate the risk of rot outbreak. Plaster boarding and skim should then be reinstated prior to redecoration.

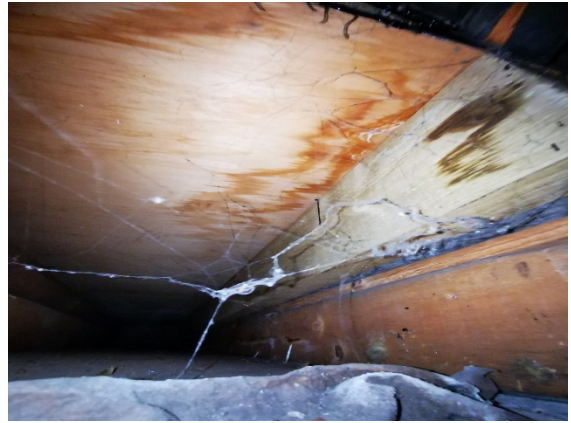
View of flat roof void.
