Fourth Wall Bespoke //  
**BUILDING SURVEY - RICS LEVEL THREE**

*Private Address*

Prepared by: Joshua Weston BSc (Hons) MRICS  
Fourth Wall Building Consultancy

Inspection Date: XX January 2022

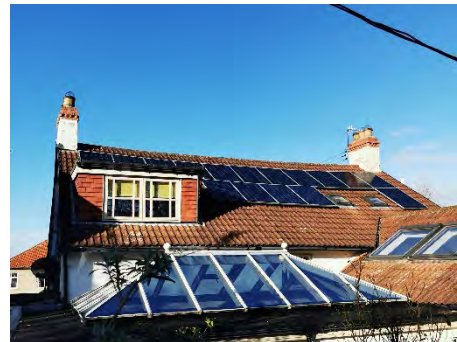
View of rear roof pitch.

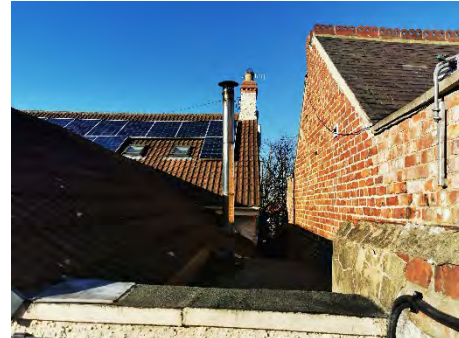
View of flat roof to rear extension.

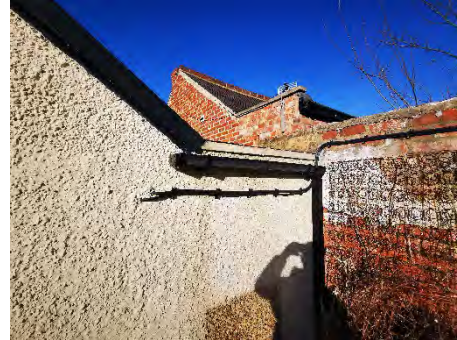
*View of guttering to rear extension flat roof.*

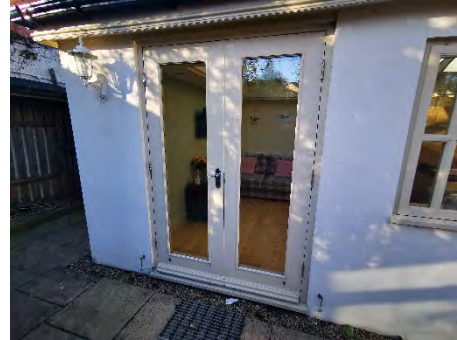
*View of rear double leaf door serving kitchen extension.*

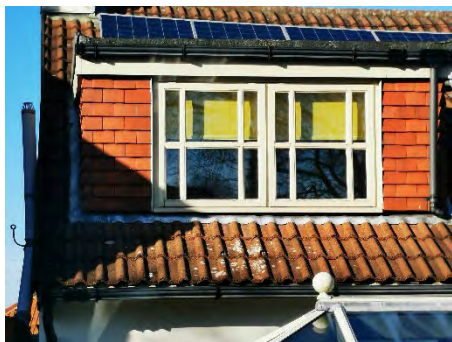
View of fascia to rear dormer.

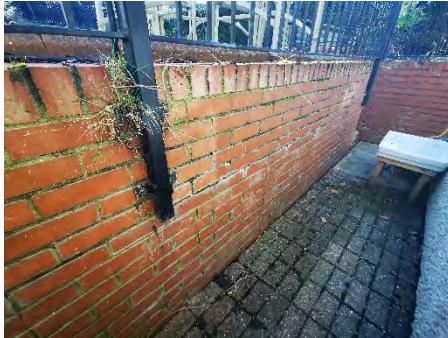
- The retaining walls to the front and rear garden appear to be in a fair condition with minor soiling noted.

View of rear retaining wall.

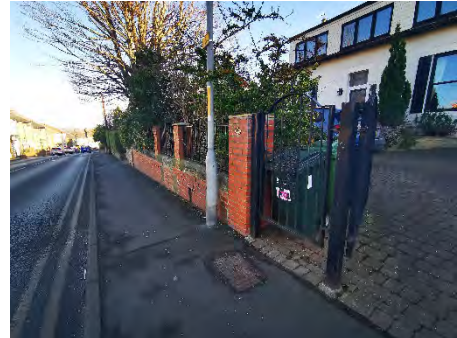
View of front boundary wall.

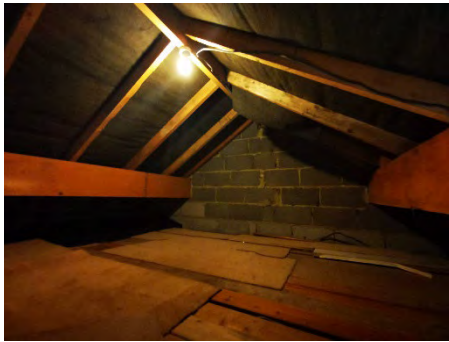
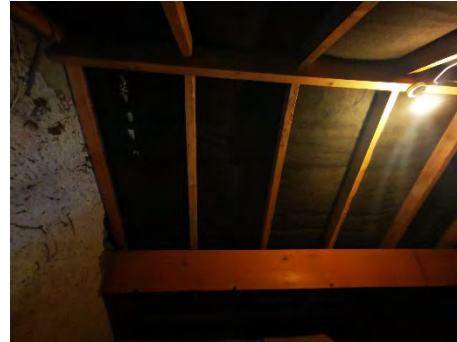
- The substructure to the secondary extension roof appears to be in a fair condition. ●

View of secondary roof sub-structure.

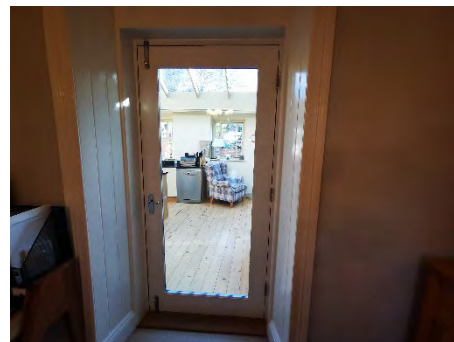
View of door serving kitchen.

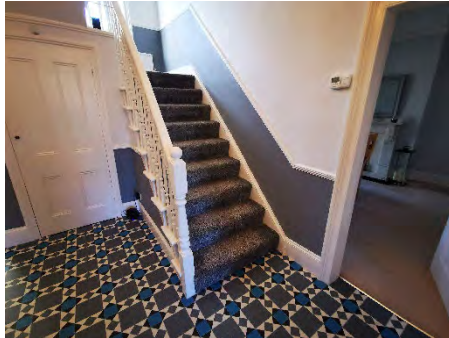
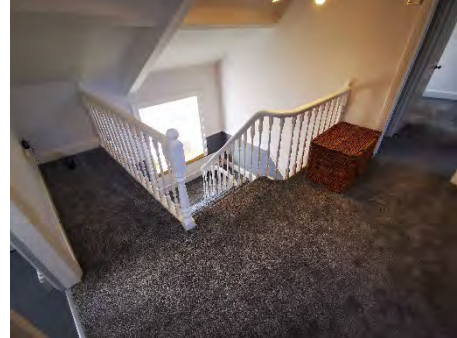
View of main staircase.

- The main staircase generally appears to be in a fair condition. ●

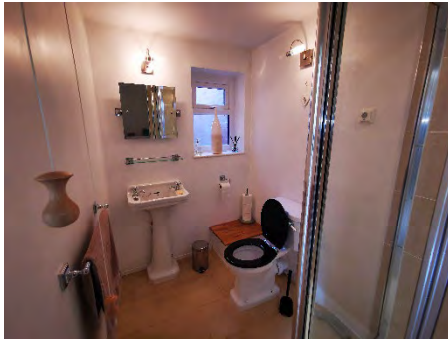
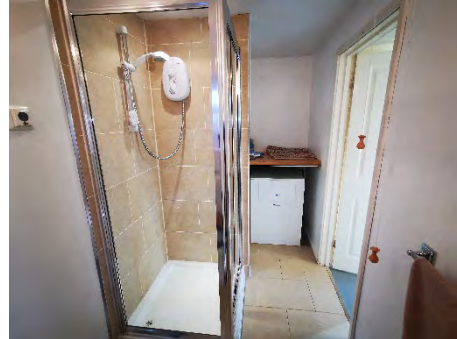
View of ground floor bathroom.

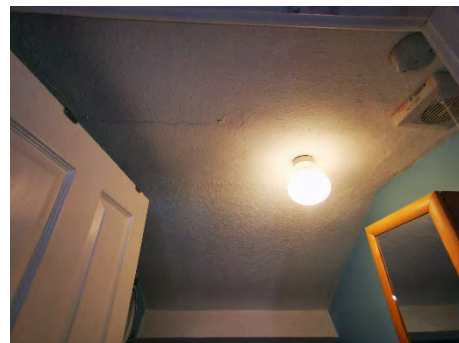
View of en-suite bathroom.

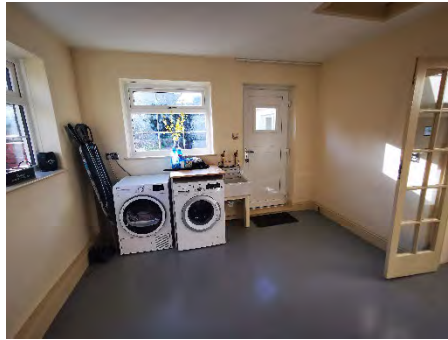
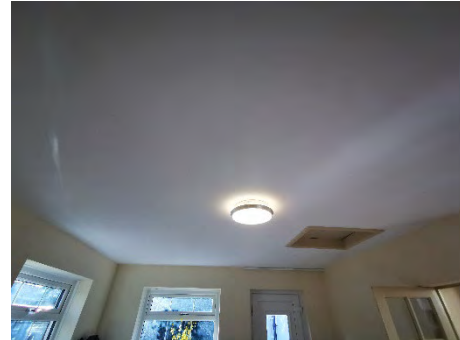
View of utility room.

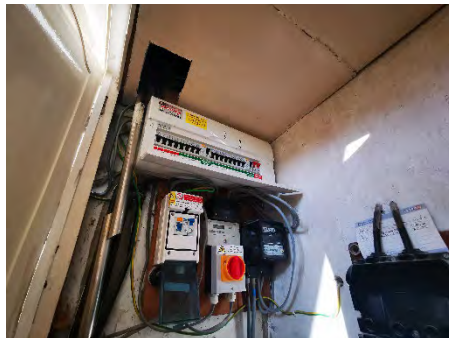
- The electrical installations generally appear to be in a fair condition with no visual defects noted.

*View of electrical supply location.*

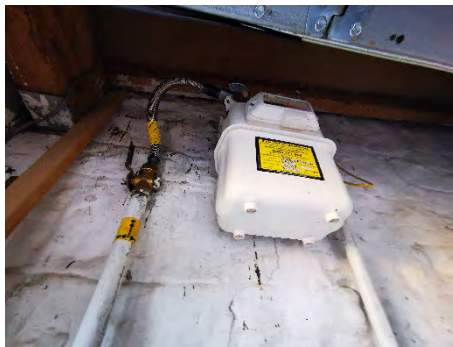
View of gas supply location.

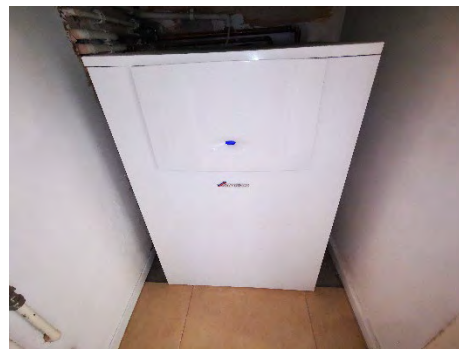
View of boiler.

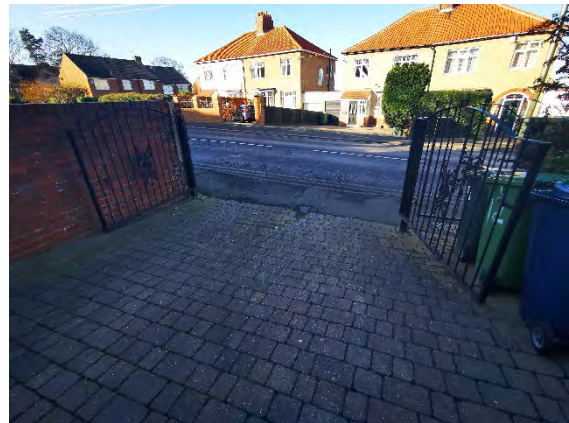
16. Paved driveway to front of site .

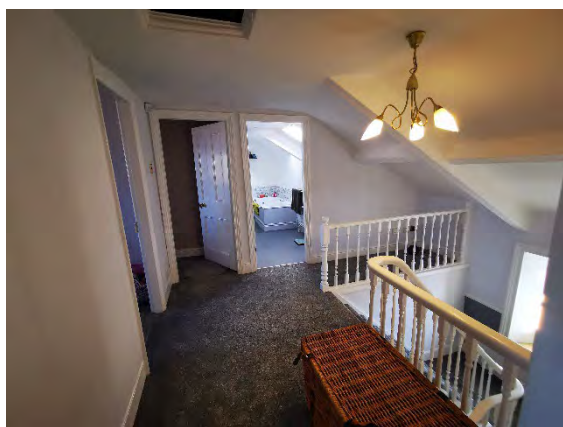
25. First floor landing.
