Fourth Wall Bespoke // BUILDING SURVEY - RICS LEVEL THREE

Of the premises known as //
Private Address

Prepared by: Joshua Weston BSc (Hons)MRICS
Fourth Wall Building Consultancy
Telephone: +44 (0)161 706 1131
Email: joshua.weston@fourthwallbc.com
Inspection Date: 6th September 2022
Report Issue Date: 9th September 2022

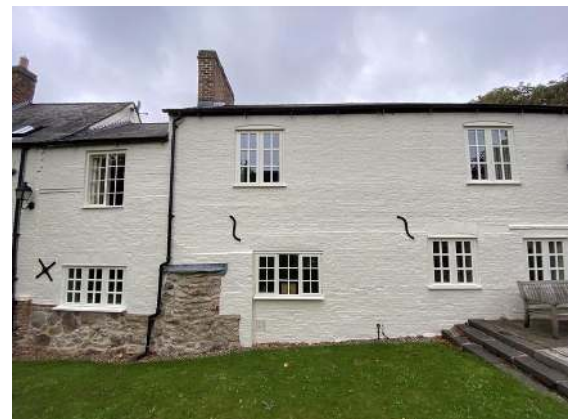
- We noted wall plates located to the external walls of the property, namely the front and rear. This suggests that the building experienced lateral movement historically and we anticipate the wall plates were installed retrospectively as a remedial measure.

Wall plate installation

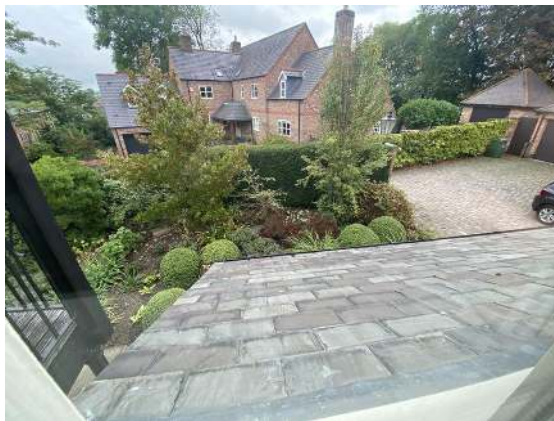
- The roof coverings to the porch areas generally appears to be in a fair condition. ●

Front porch roof covering

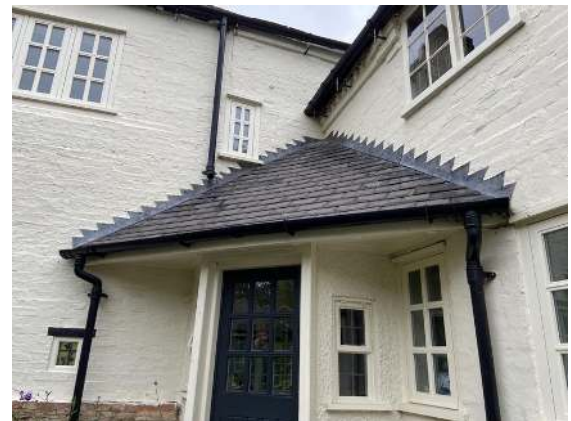
Side porch roof covering

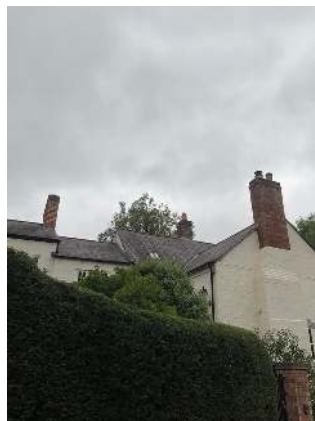
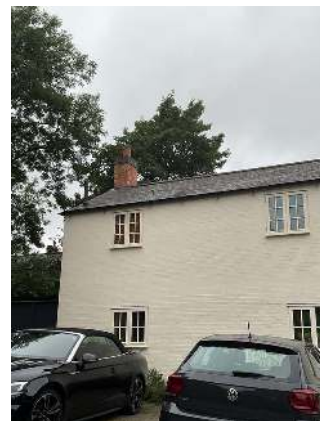
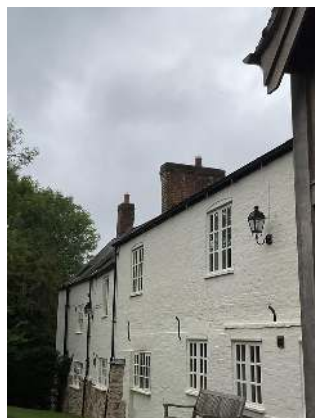
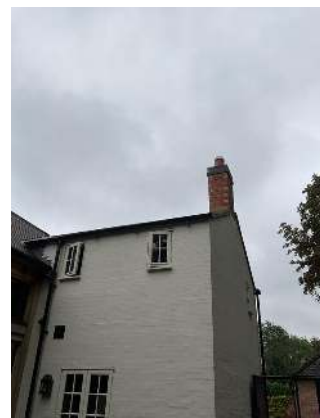
- The chimneys generally appear to be in a fair condition given the property's age.

View of chimney stacks

View of chimney stack

View of rear chimneys

Rear view of chimneys

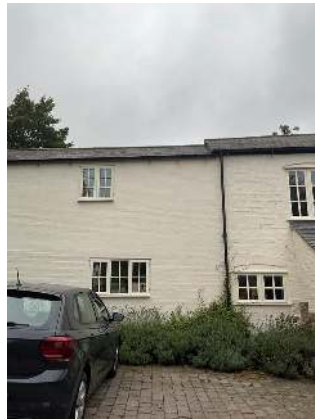
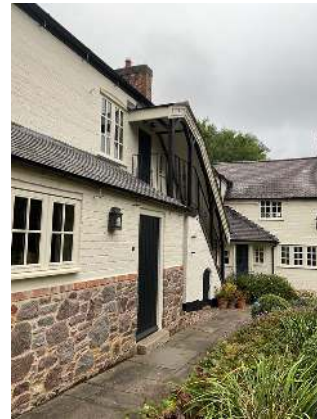
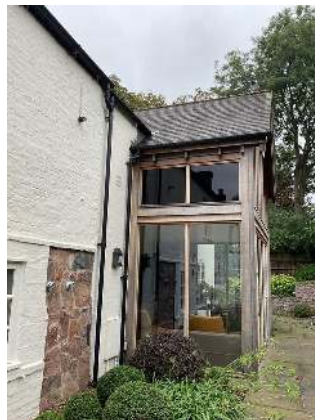
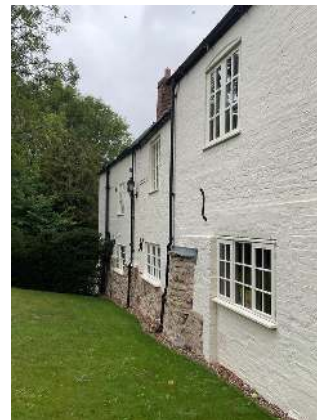
- There were no signs of water staining or runoff below the gutters or overflow weirs to suggest any problems associated with the capacity of the gutters. The gutters and overflow weirs appeared to be in reasonable condition and will provide early warning when the rainwater outlets become blocked or the gutters cannot take the amount of water being discharged into them.

Front elevation rainwater goods

Rear elevation rainwater goods

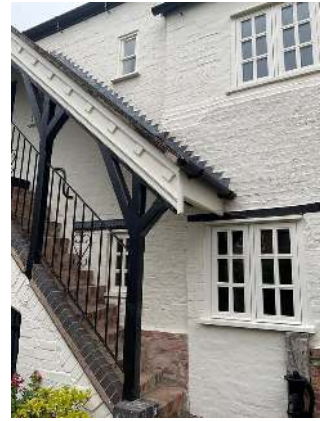
- The roof which serves the external front steps has a gutter located at the base of arrangement. The gutter is not provided with a downpipe and therefore does not have an effective way to remove the rainwater from the external fabric. We recommend a downpipe is installed to drain the water directly into an underground drain arrangement to ensure rainwater is being disposed of effectively.

Gutter with no downpipe

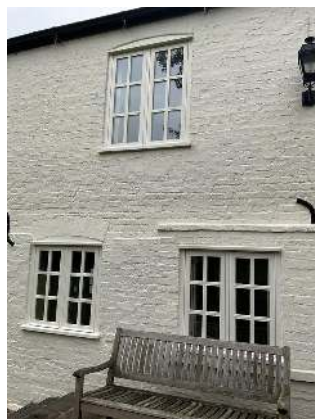
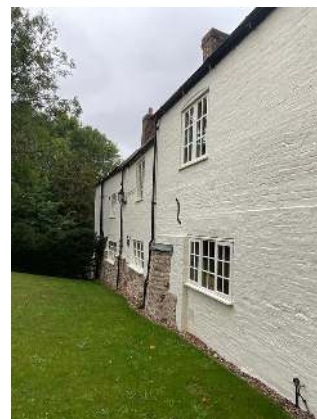
- The windows appear to be in a fair condition. A sample of windows were tested and found to be operable at the time of inspection.

Timber windows

Rear elevation windows

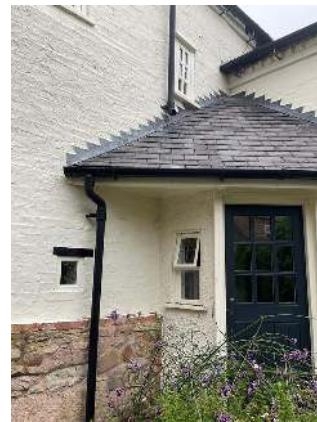
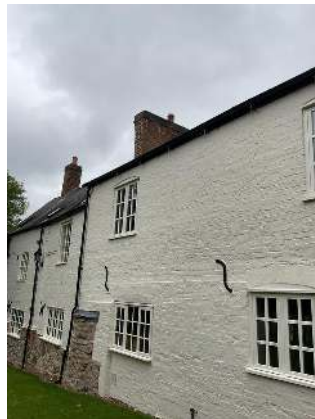
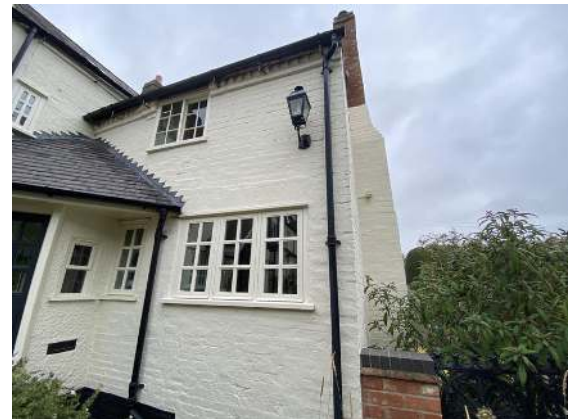
- The timber fascias and brick gutter shelves appear to be in a fair condition. ●

Timber fascia

Timber fascias and brick gutter shelf

Rear elevation external joinery

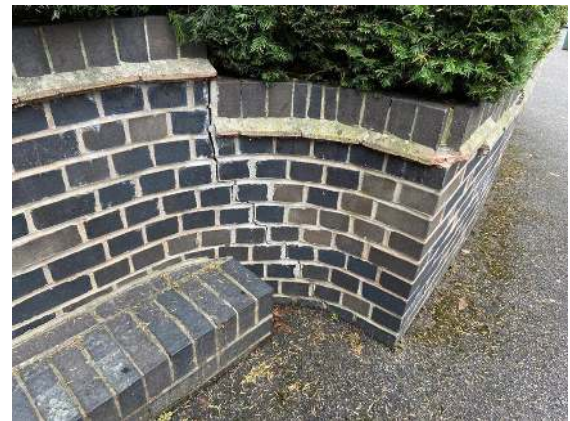
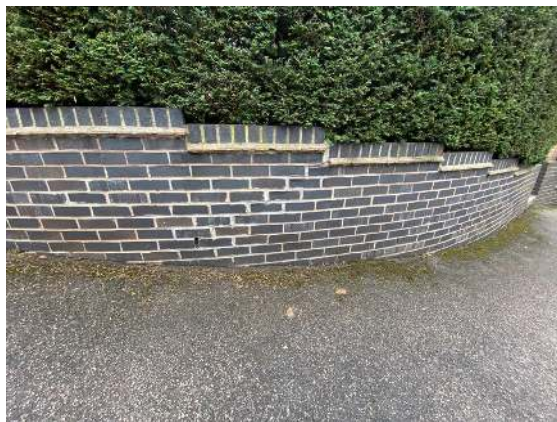
(iv)	The boundary wall exhibits signs of lateral movement at the mid-section. This appears to have been repointed which has since reopened, which would suggest movement is progressive. We anticipate the movement has occurred due to the curved form of the wall, which may have been aggravated by the close proximity of boarder plants. Given the age of the wall and its condition, we do not believe this presents an immediate threat of collapse. However, we recommend you budget to have helibar ties installed to provide additional support to the structure and engage an arboriculturist to advise regarding the management of adjacent privet to mitigate against further movement.	Purchaser	●

- The boundary wall exhibits signs of lateral movement at the mid-section. This appears to have been repointed which has since reopened, which would suggest movement is progressive. We anticipate the movement has occurred due to the curved form of the wall, which may have been aggravated by the close proximity of boarder plants. ●

Boundary wall movement

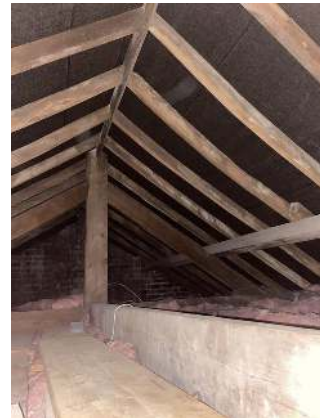
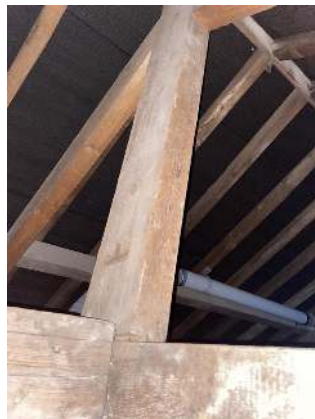
Main roof void accessed via first floor landing

- The substructures appears to be in a fair condition.

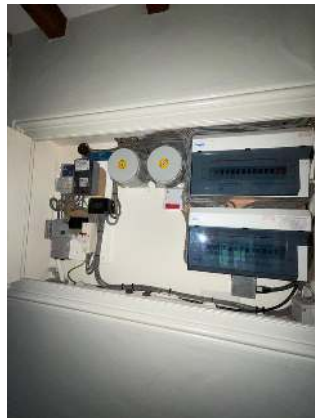
Electrical supply and consumer unit

- The electrical installations generally appear to be in a fair condition with no visual defects noted. ●

Whilst the electrical services generally appear free from visual defects, we have not undertaken any testing of the electrical systems to verify their condition or safety. We recommend your solicitor requests copies of the electrical installation condition report (EICR) and subsequent testing relating to the property from the vendor.

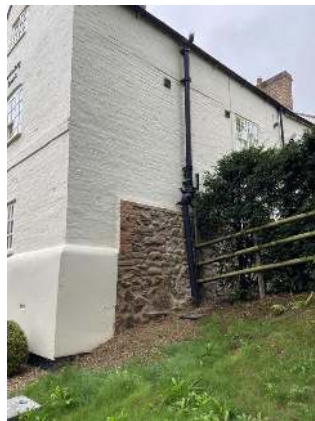
Soil and vent pipe

- The soil and vent pipe appears to be in a fair condition. ●

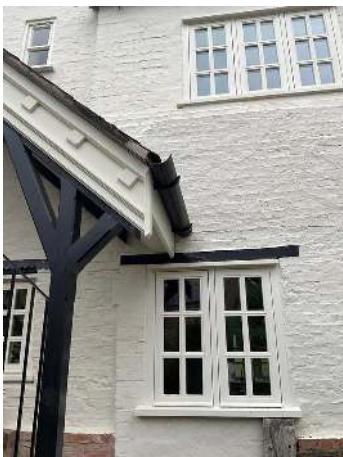
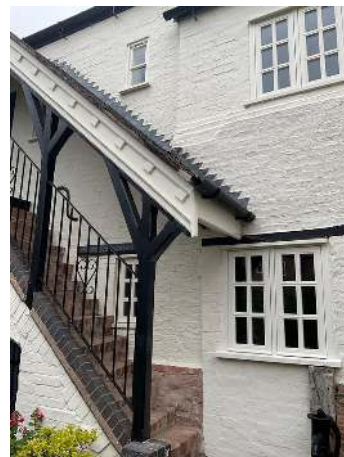
23. Gutter with no downpipe

24. Gutter with no downpipe

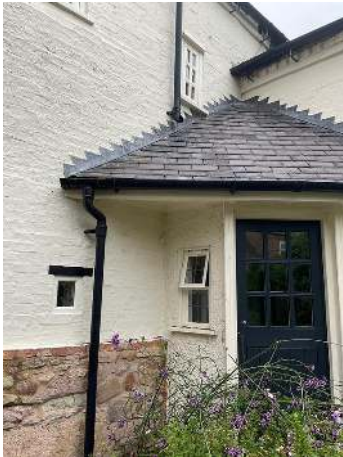
33. Timber fascias and brick gutter shelf

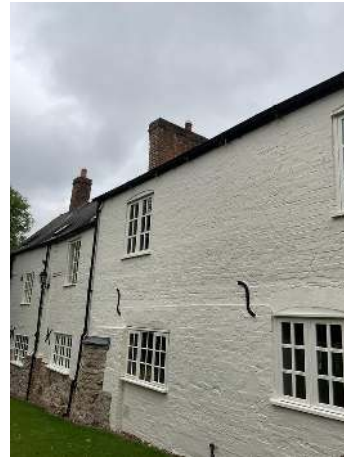
34. Rear elevation external joinery

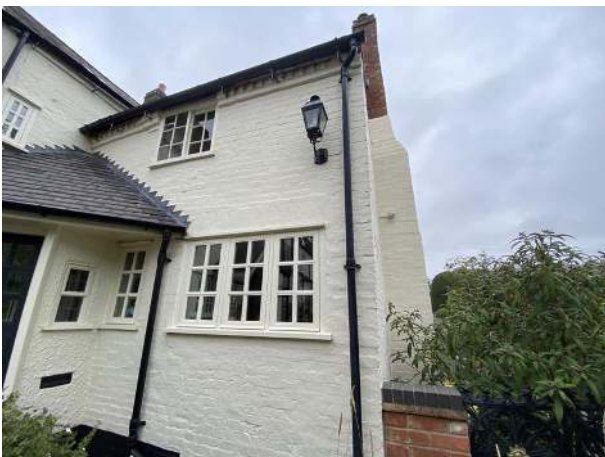
35. Timber fascias and brick gutter shelf

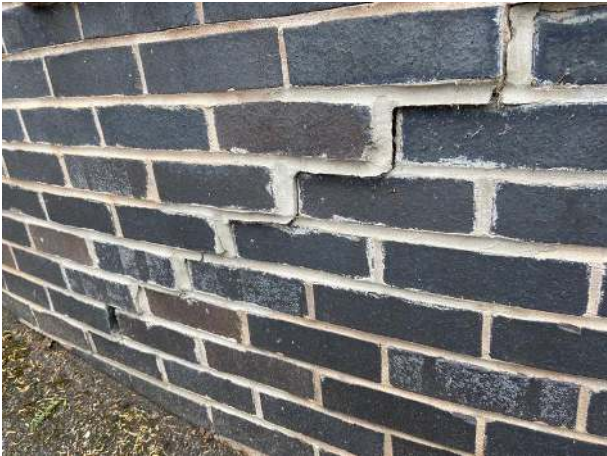
43. Boundary wall movement

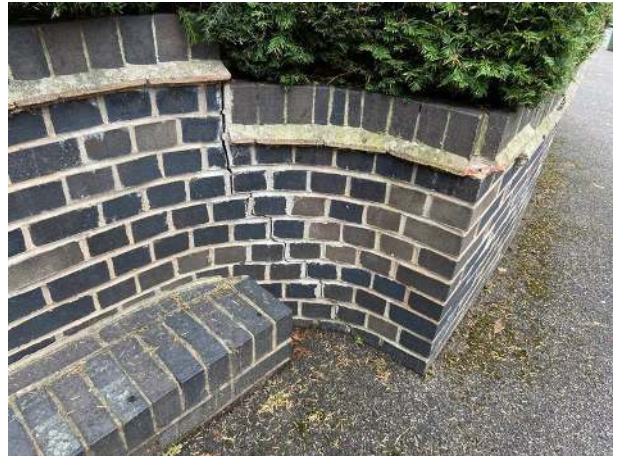
44. Boundary wall movement

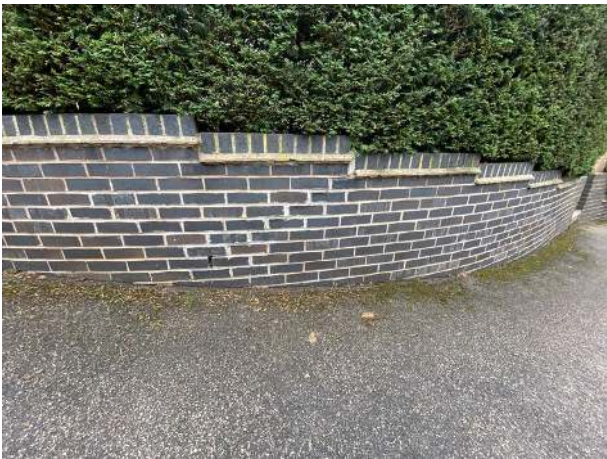
45. Boundary wall movement

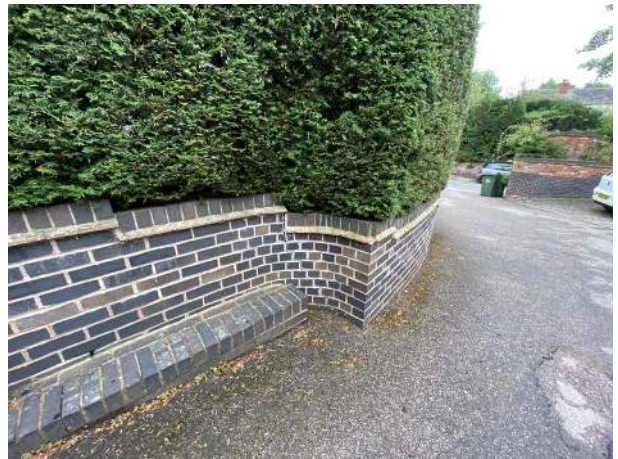
46. Boundary wall movement

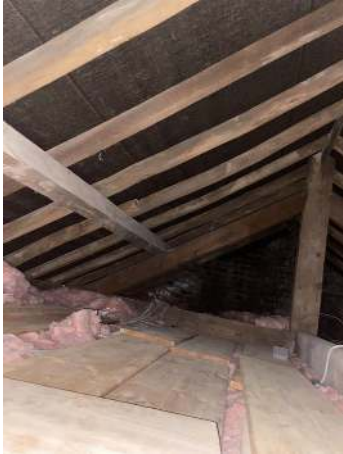
61. Main roof void accessed via first floor landing

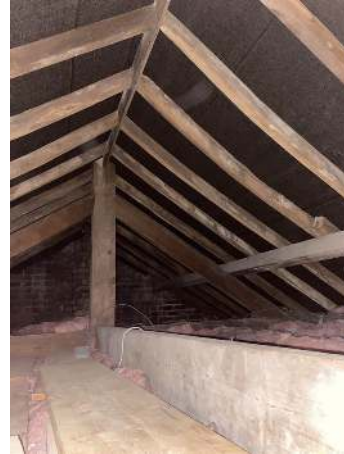
62. Main roof void accessed via first floor landing

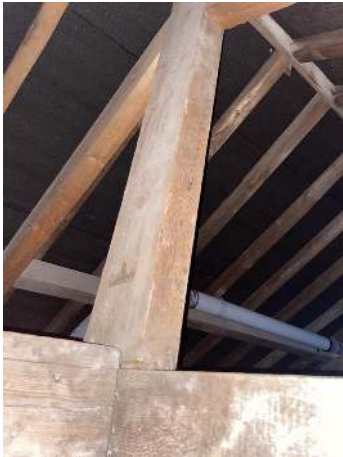
63. Main roof void accessed via first floor landing

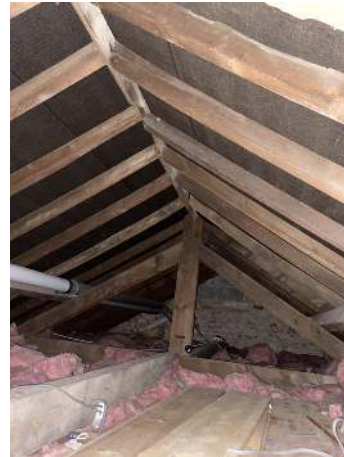
64. Main roof void accessed via first floor landing

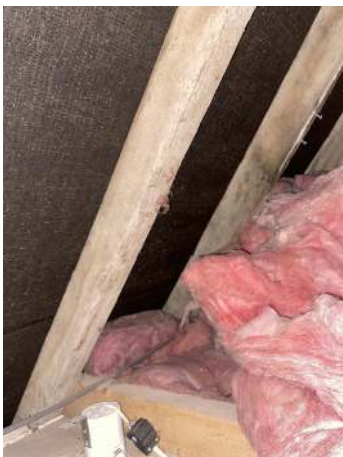
65. Second floor bedroom roof void

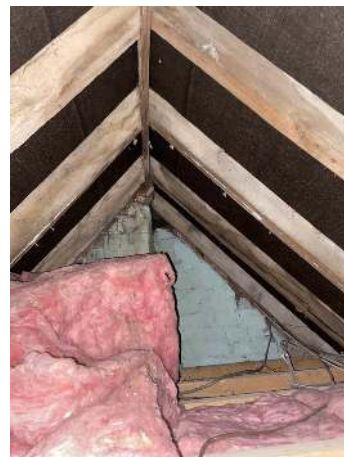
66. Second floor bedroom roof void

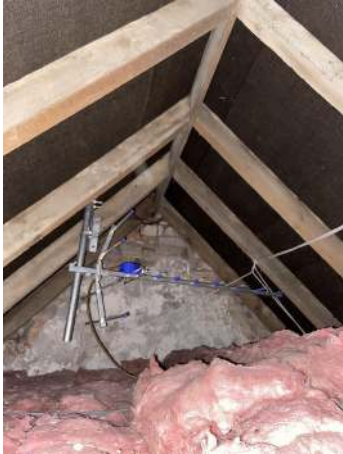
67. Second floor bedroom roof void

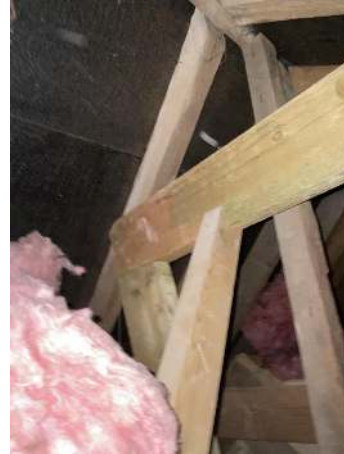
68. Second floor bedroom roof void

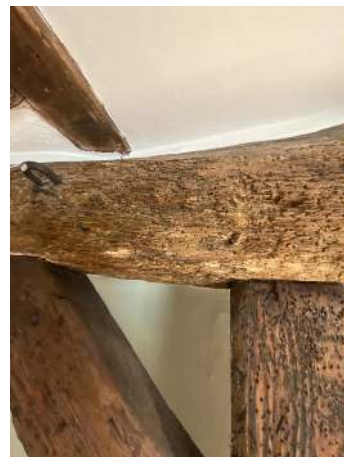
As highlighted we noted evidence of wood boring beetle infestation to the property.

77. Evidence of wood boring beetle within first floor bathroom
