Fourth Wall Bespoke //  
**BUILDING SURVEY - RICS LEVEL THREE**

*Private Address*

Prepared by: Joshua Weston BSc (Hons) MRICS  
Fourth Wall Building Consultancy

Inspection Date: XX January 2022

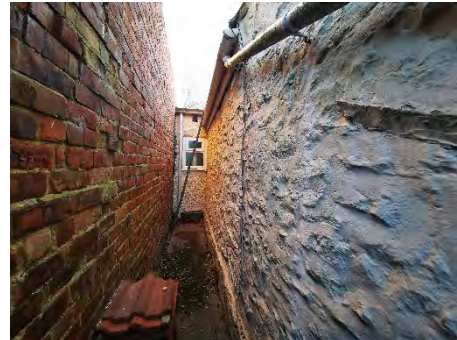
*View of render finish to side elevation.*

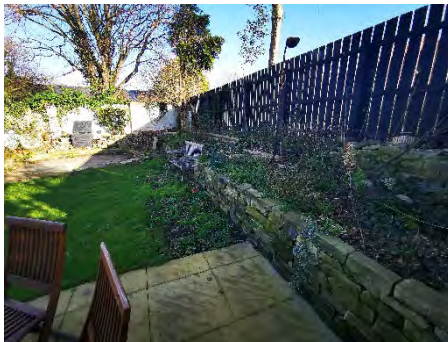
- The timber gate and fence to the rear boundary generally appear to be in a fair condition.

View of rear fence.

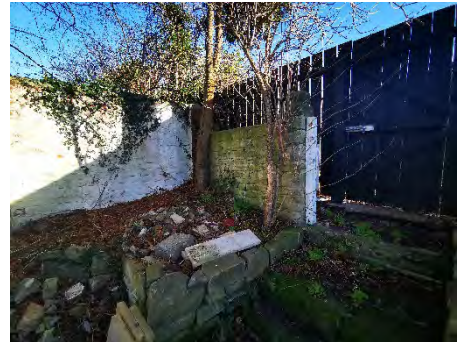
View of rear gate.

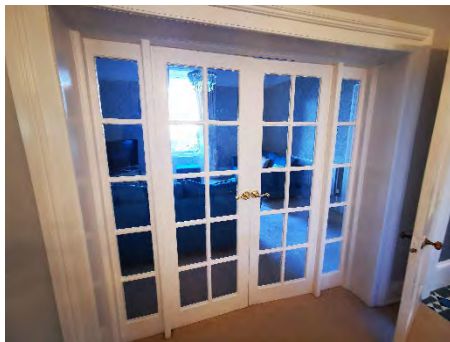
- The internal doors generally appear to be in a fair condition and were operable at the time of inspection. ●
- Architraves and skirting appear to be in a fair condition. ●
- We did not note a safety mark to the glazing to the doors serving the reception room in line with BS 6262-4, the British Standard code of practice for safety related to human impact for glazing in buildings. We recommend the glazing is replaced with safety glazing to comply with current standards and regulations to reduce the risk of injury in the event of impact. ●

View of door serving reception room.

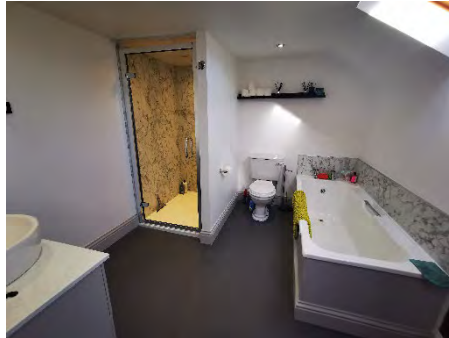
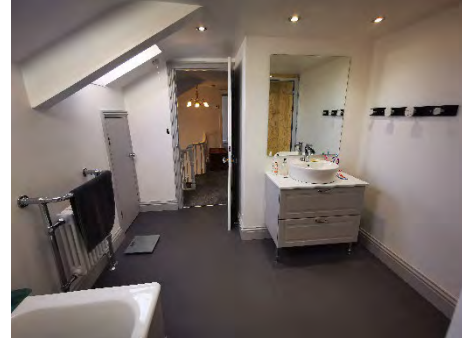
View of main bathroom.

- The finishes generally appear to be in a fair condition. ●
- The fittings generally appear to be in a fair condition. ●
- We noted the bathrooms and toilet are provided with mechanical extraction to reduce moisture levels to this area. The extractor installation appears to be in a fair condition and in line with current regulations at the time of our inspection, based upon visible elements of the installation. ●

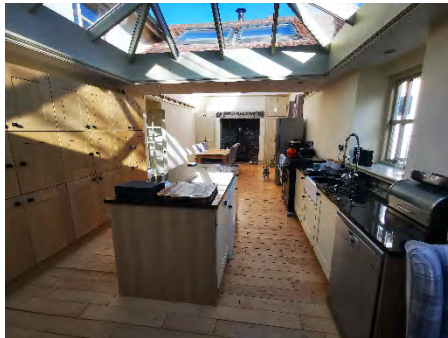
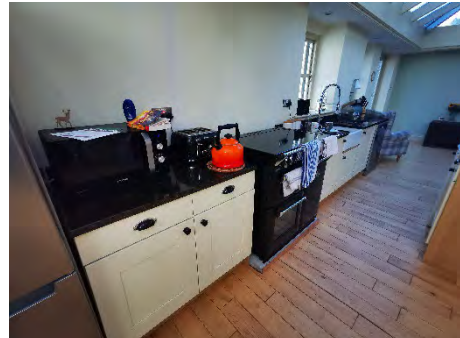
View of kitchen.

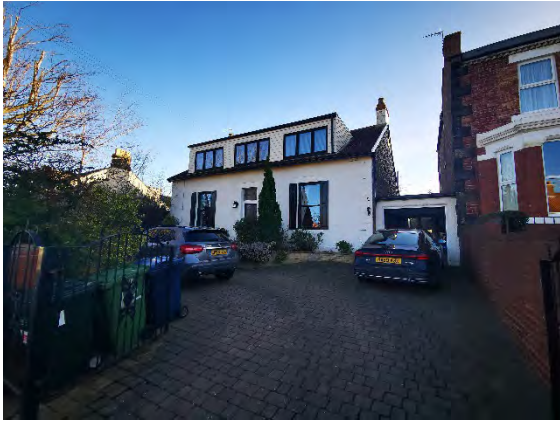
1. Front elevation.

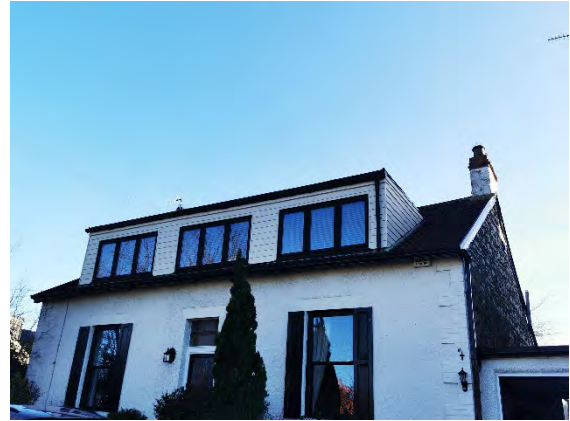
2. Front roof pitch.

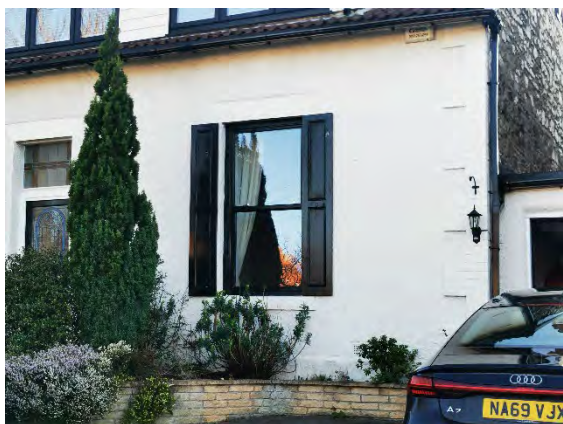
5. Render finish to front elevation.

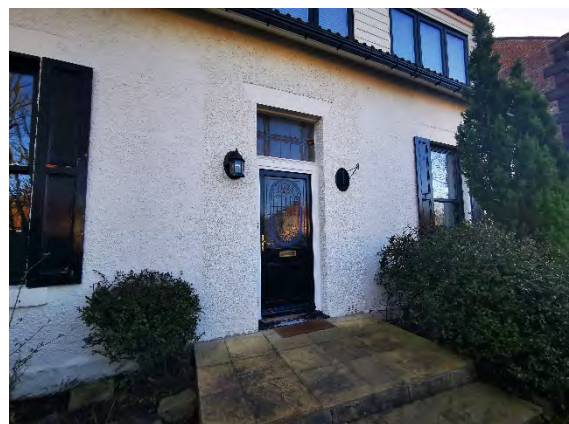
6. View of front elevation.

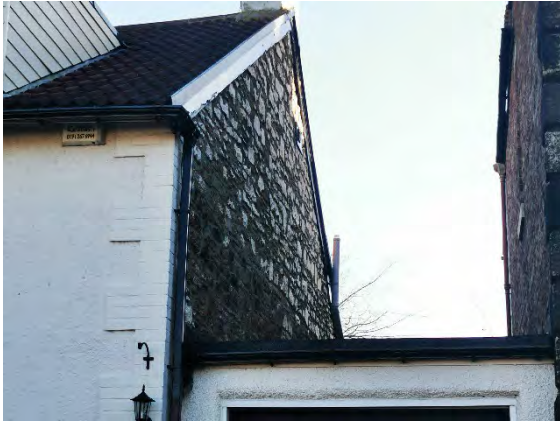
7. Side elevation.

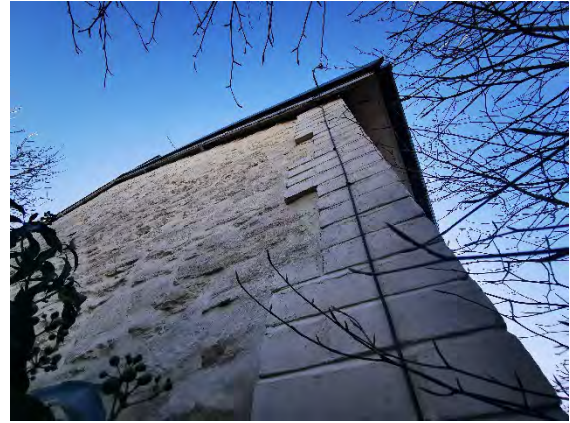
8. Side elevation.

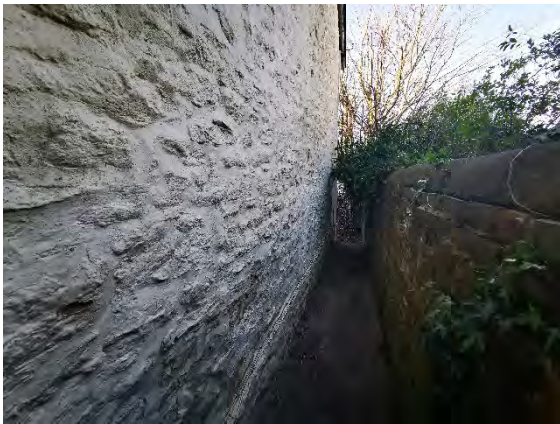
9. Side elevation.

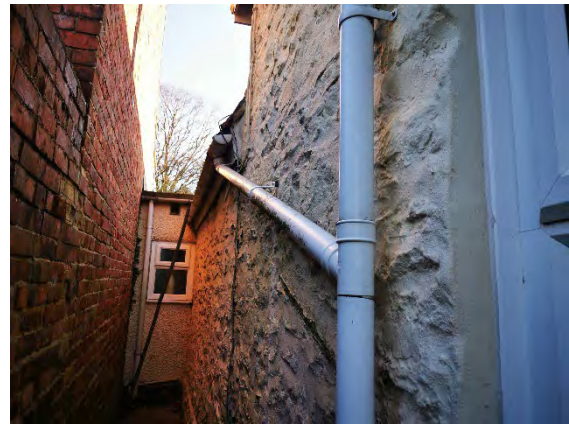
10. Side elevation.

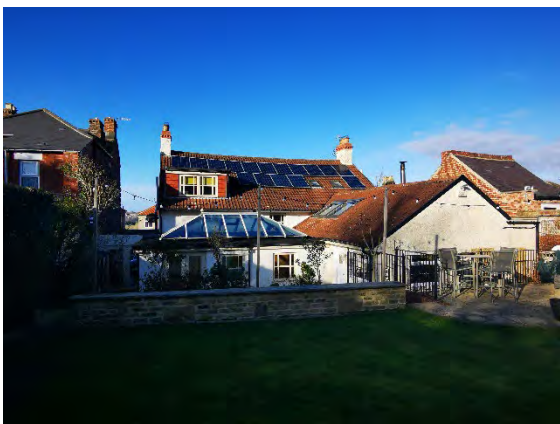
11. Rear elevation.

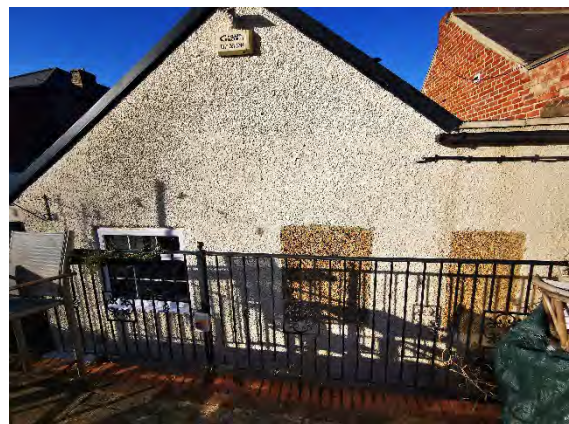
12. Rear elevation.

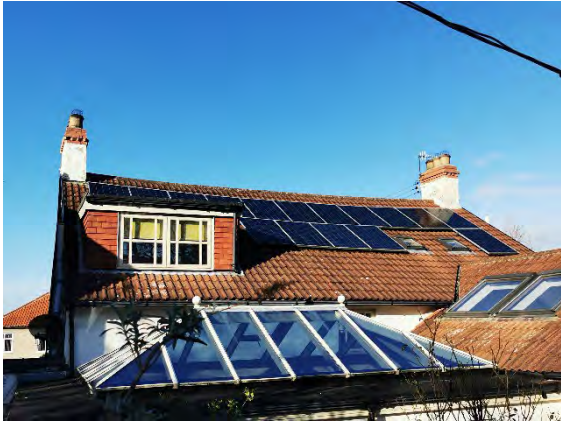
13. Rear roof pitches.

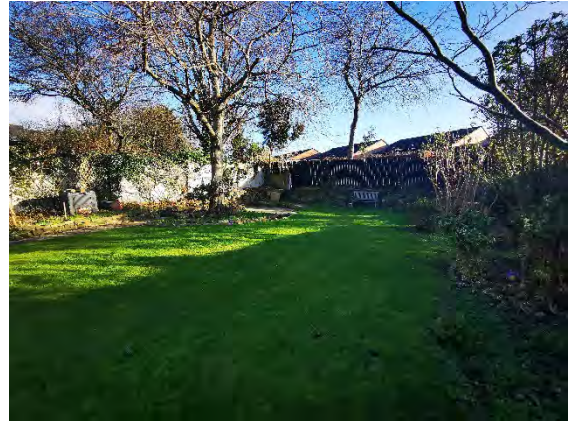
14. View of rear garden.

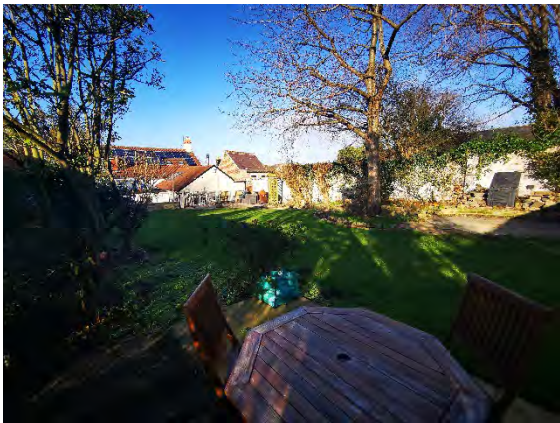
15. View of rear garden.

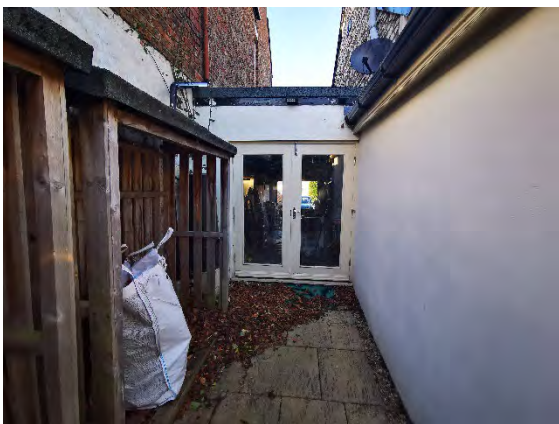
17. View of rear elevation to garage.

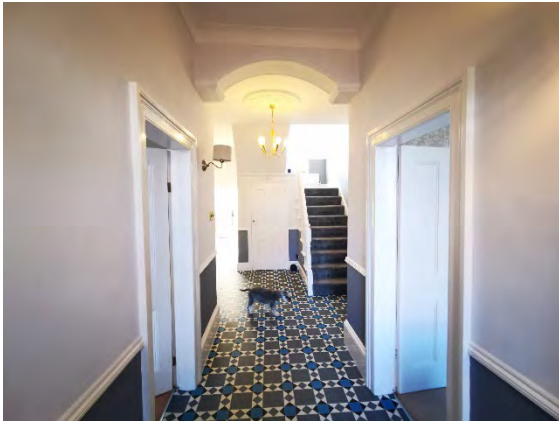
19. Entrance hall.

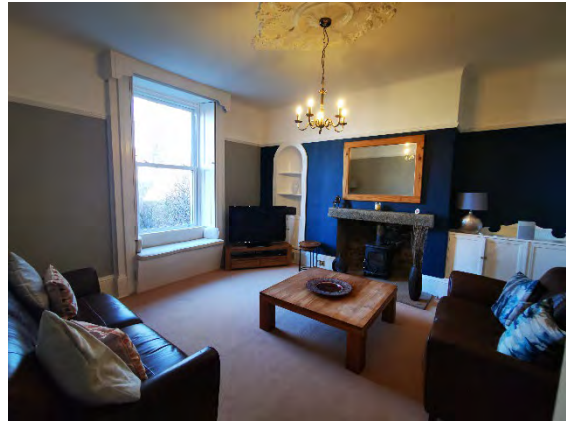
20. Front reception room.

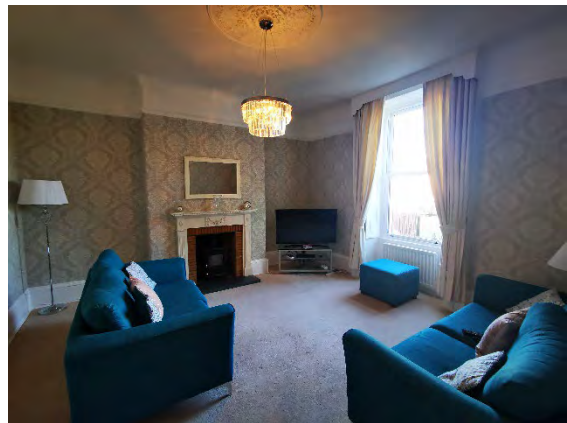
22. Front reception room.

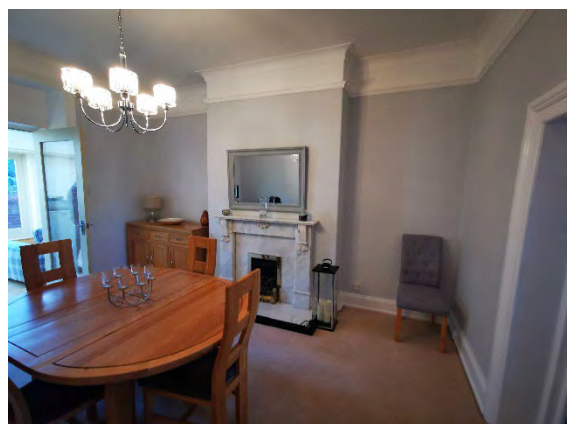
24. Rear reception room.

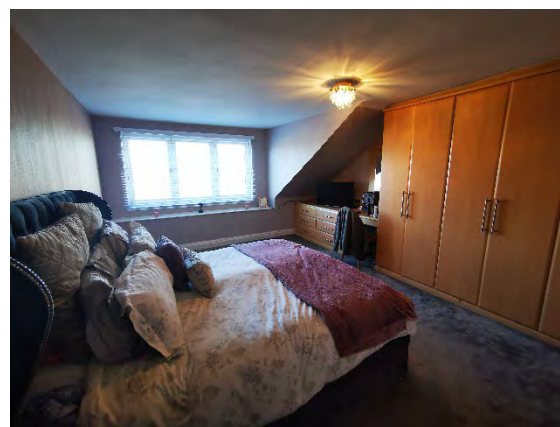
26. Front principal bedroom.

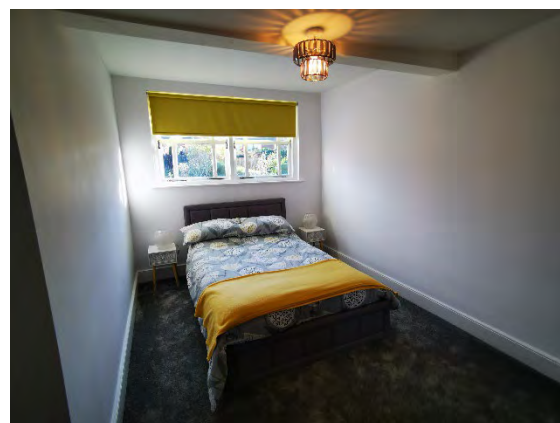
28. Rear bedroom.

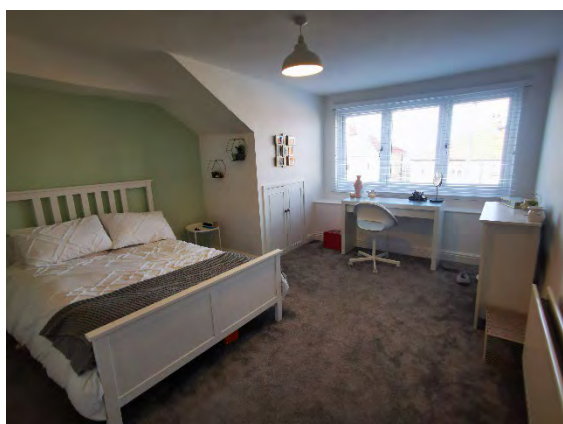
29. Front first floor bedroom.

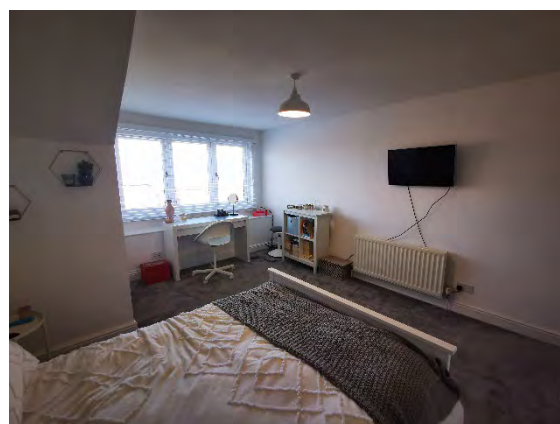
30. Front first floor bedroom.
