Fourth Wall Bespoke // BUILDING SURVEY - RICS LEVEL THREE

Of the premises known as //
Private Address

Prepared by: Joshua Weston BSc (Hons)MRICS
Fourth Wall Building Consultancy
Telephone: +44 (0)161 706 1131
Email: joshua.weston@fourthwallbc.com
Inspection Date: 6th September 2022
Report Issue Date: 9th September 2022

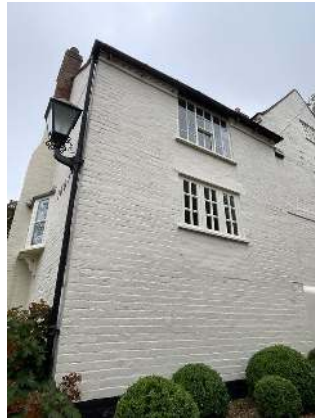
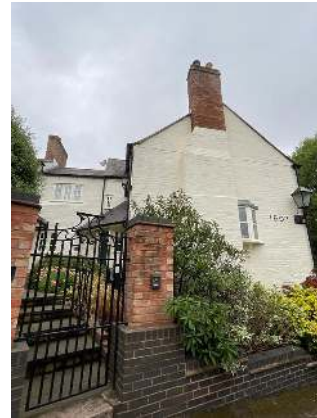
Side elevation

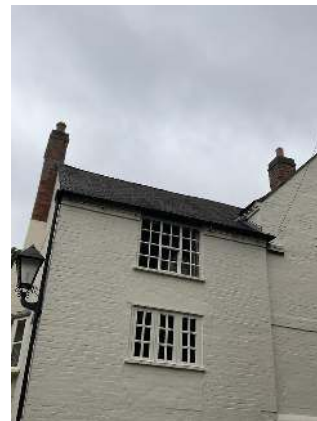
Side elevation roof

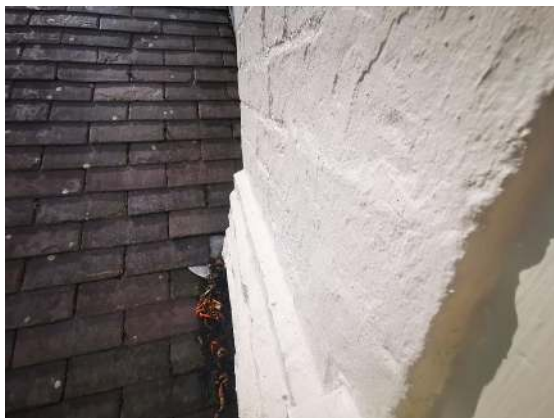
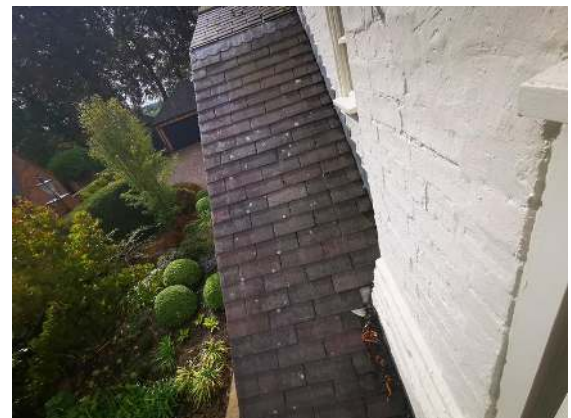
- The roof covering to the external steps generally appears to be in a fair condition. ●

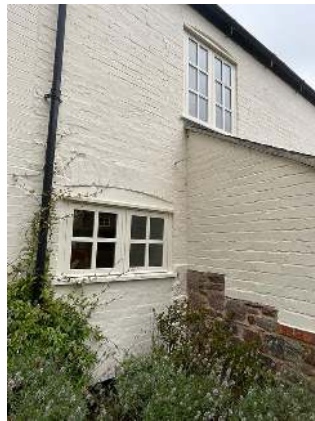
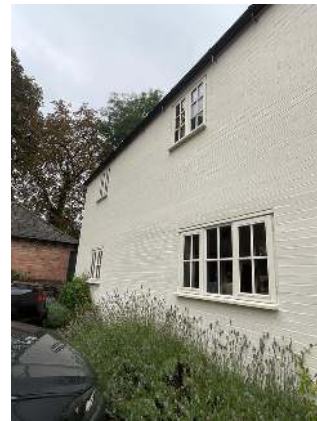
- The windows appear to be in a fair condition. A sample of windows were tested and found to be operable at the time of inspection.

Timber windows

Rear elevation windows

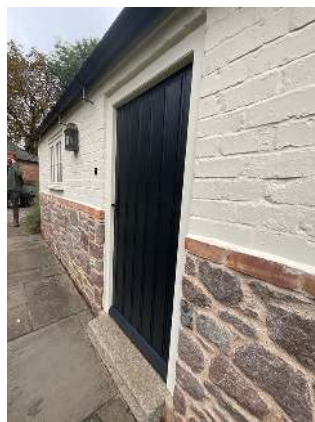
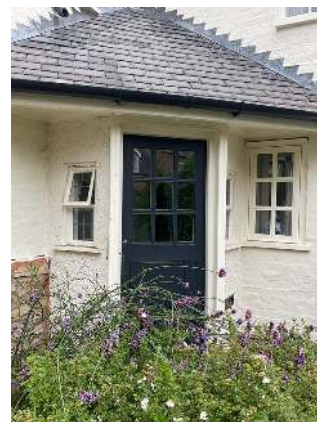
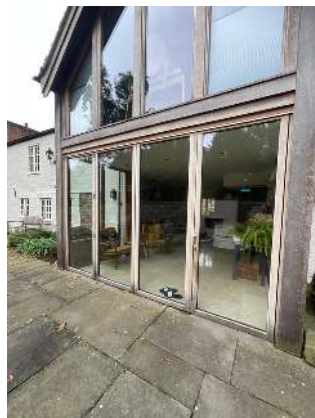
- The doors appear to be in a fair condition. A sample of doors were tested and found to be operable at the time of inspection.

Front external door

Rear external door

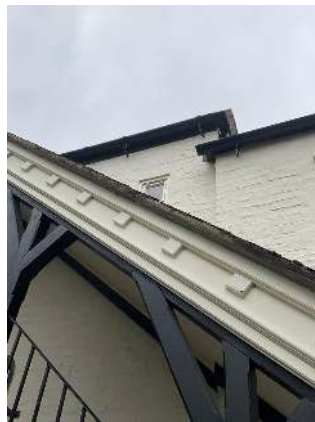
- The timber fascias and brick gutter shelves appear to be in a fair condition. ●

Timber fascia

Timber fascias and brick gutter shelf

Rear elevation external joinery

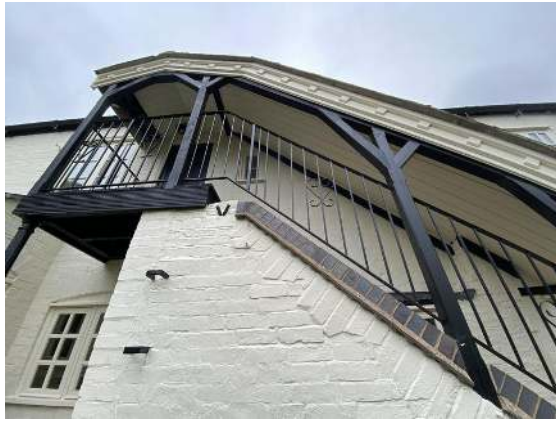
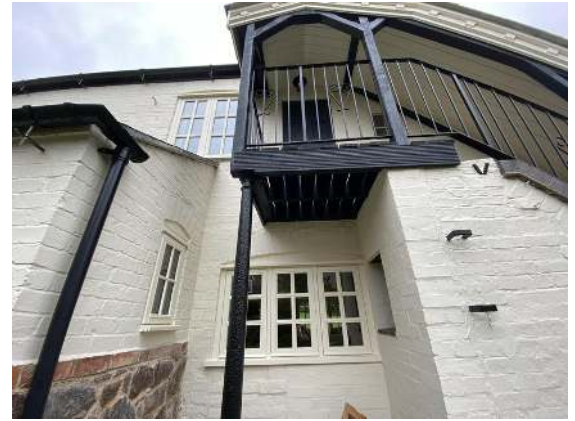
- The external joinery serving the front extension appears to be in a generally fair condition. ●

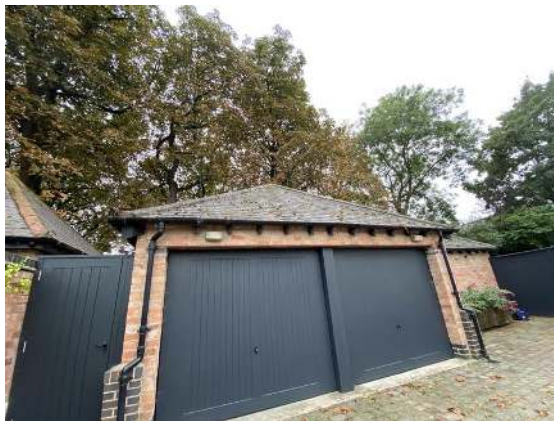
- The garage doors appear to be in a fair condition at the time of inspection and were operational. Generally the garage roof, rainwater goods, main walls and floor construction appears to be in a fair condition. ●

Garage doors

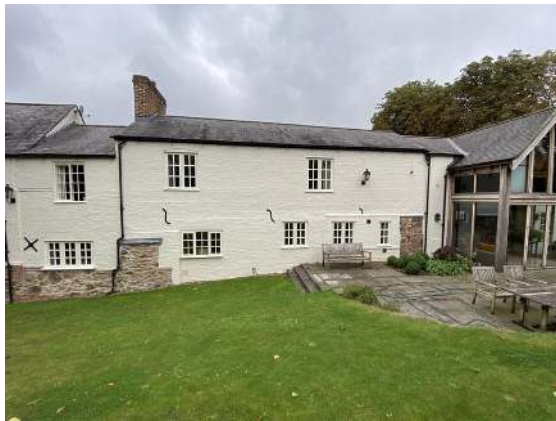
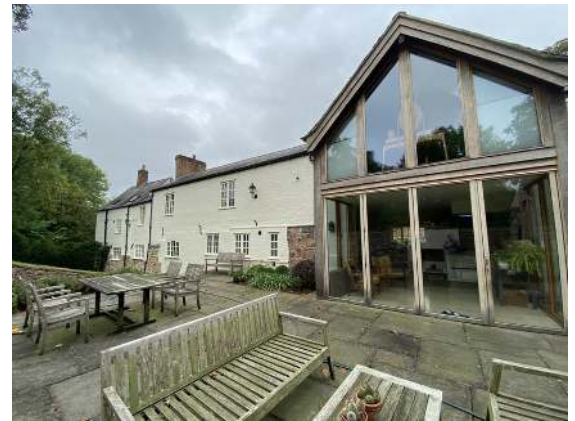
- The covering to the rear patio generally appear to be in a fair condition. ●

Rear patio

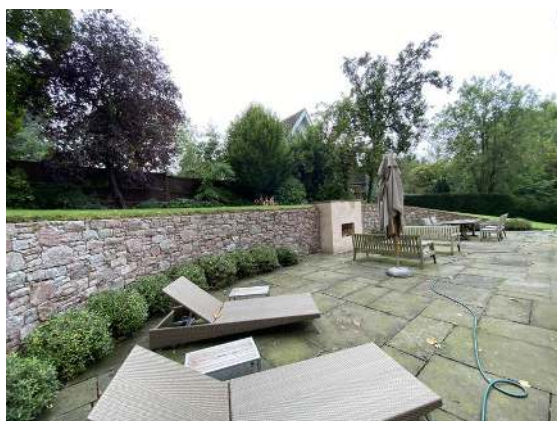
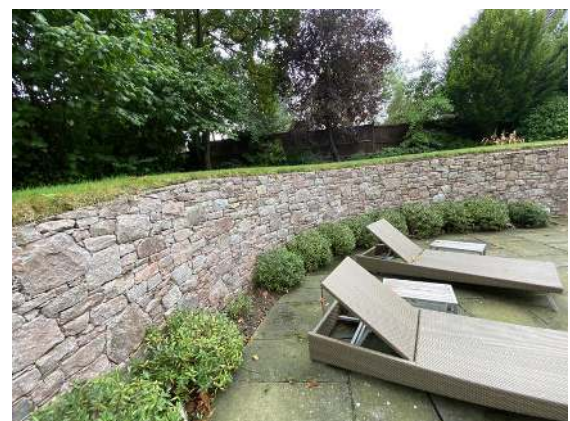
- The vehicle and pedestrian gates generally appear to be in a fair condition and were operable at the time of inspection. ●
- The retaining wall to the garden generally appears to be in a fair condition. ●

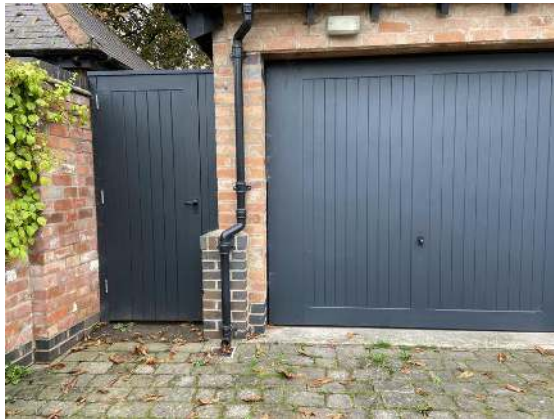
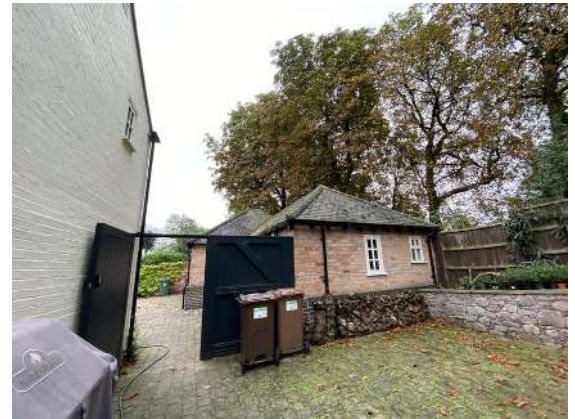
- The the single leaf gate to the bin store and double leaf gate to the side elevation which provides access into the garden appears to be in a fair condition and were operable at the time of inspection.

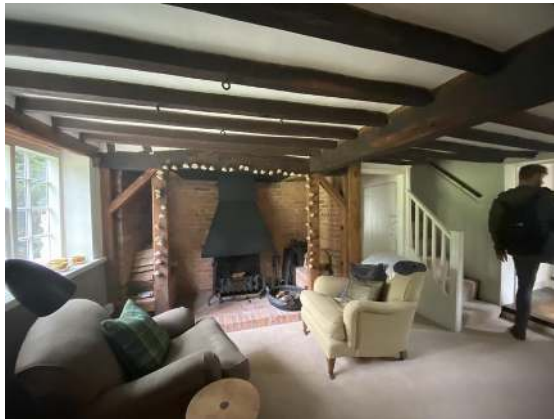
Ground floor

- We did not note any significant bounce or deflection to the suspended timber floors to suggest any issues with the underlying construction. ●

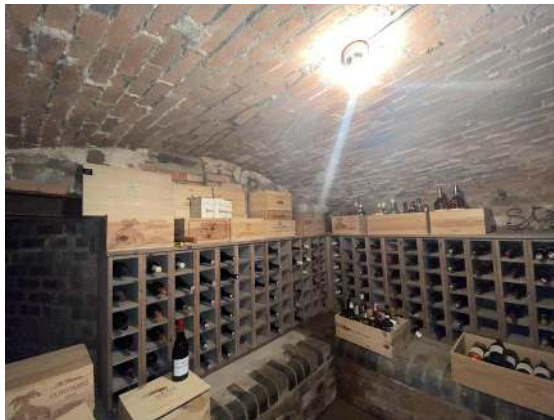
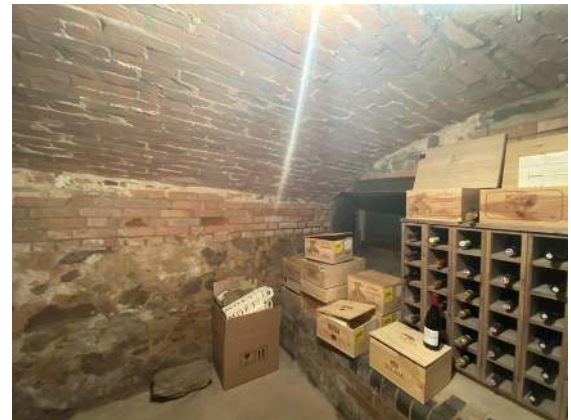
- The vaulted brick floor serving the reception room was accessible via the cellar and generally appears to be in a fair condition. ●

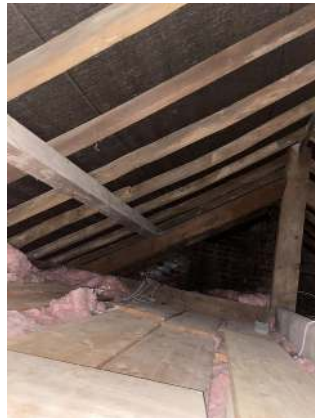
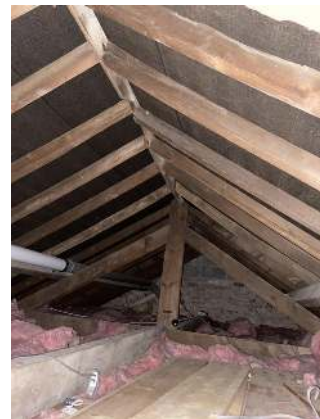
Main roof void accessed via first floor landing

- The substructures appears to be in a fair condition.

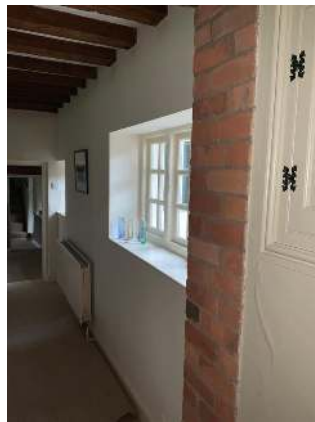
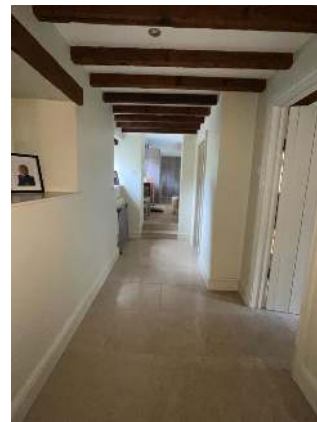
Internal walls

- The walls generally appear to be in a fair condition.

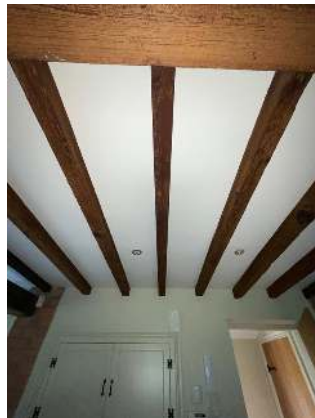
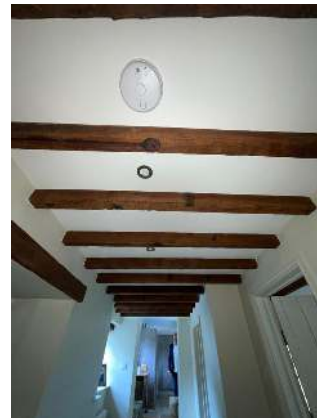
Ceilings

- The ceilings generally appear to be in a fair condition. ●

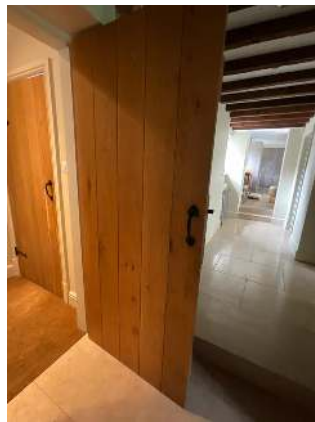
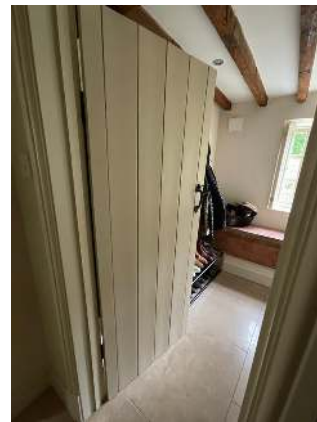
Internal door

- The internal doors generally appear to be in a fair condition and were operable at the time of inspection. ●

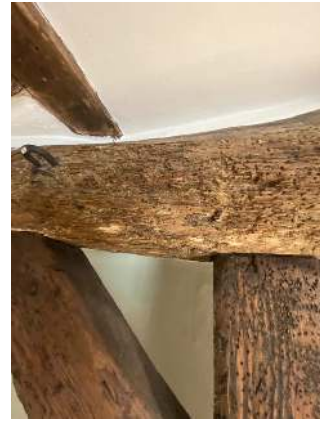
- We noted evidence of active woodboring beetle to internal joinery, specifically to the timber cladding adjoining the coal shoot to the cellar, which appears localised and does not appear to have spread to structural timber elements, such as the floor joists. Further specialist treatment to mitigate against further spread and deterioration of fabric will be required in the immediate term. We recommend your solicitor request details regarding any historic treatment of wood boring insects and any related warranties or guarantees which may be available to transfer to the purchaser upon completion of the sale. ●

Generally we noted evidence of historic wood boring beetle to timber elements within the building such as rafters, trusses, exposed lintels and timber frame – however we anticipate this to be historic and is a fairly typical observation for a property of this age.

Evidence of wood boring beetle within first floor bathroom

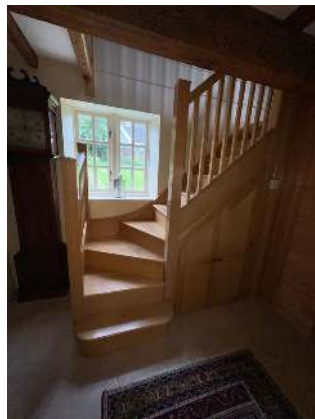
Main staircase

- The main staircases generally appears to be in a fair condition with no signs of wear noted.

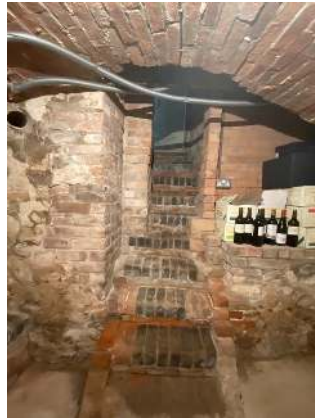
Basement staircase

- The basement staircase generally appears to be in a fair condition with signs of wear noted.

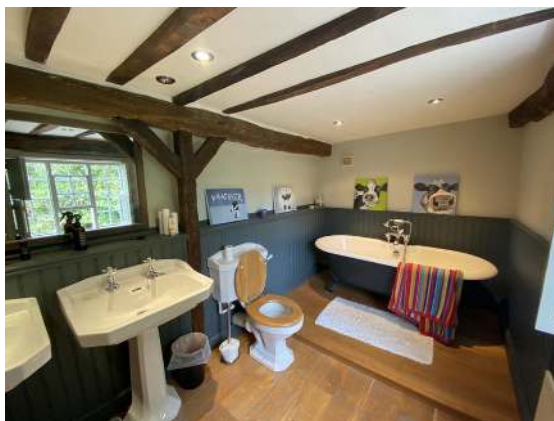
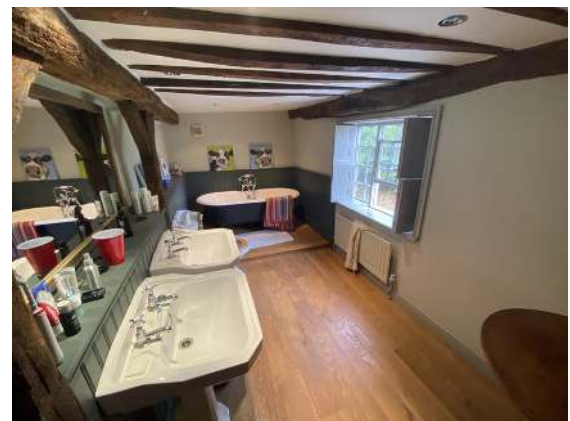
First floor en suite

- We noted the bathroom and en-suite is provided with mechanical extraction to reduce moisture levels to this area. The extractor installation appears to be in a fair condition and in line with current regulations at the time of our inspection, based upon visible elements of the installation. ●
- The finishes generally appear to be in a fair condition. ●

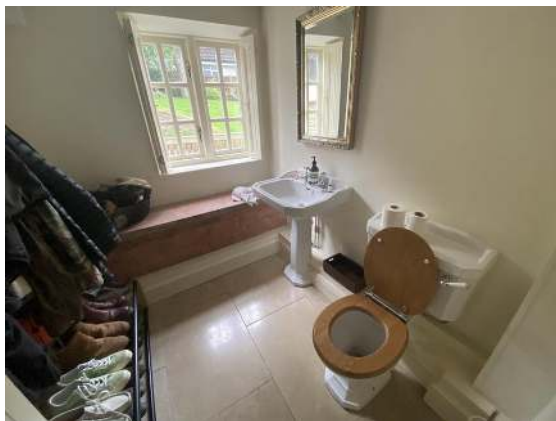
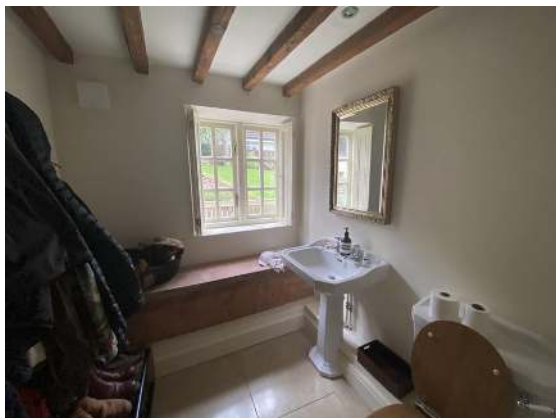
Downstairs toilet

- The fittings generally appear to be in a fair condition. ●

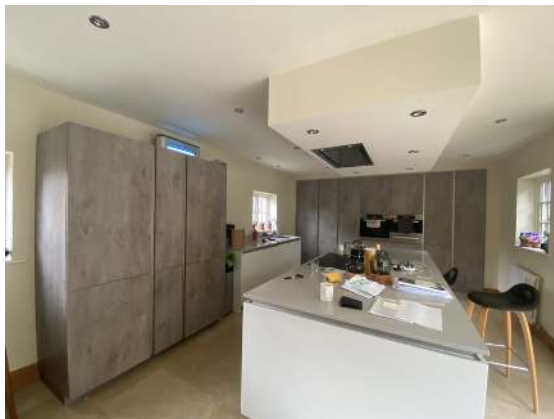
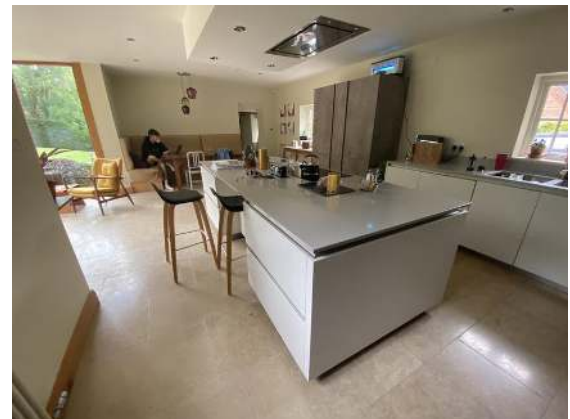
- We noted the kitchen is provided with mechanical extraction to reduce moisture levels to this area. The extractor installation appears to be in a fair condition and in line with current regulations at the time of our inspection, based upon visible elements of the installation. ●
- The finishes generally appear to be in a fair condition. ●

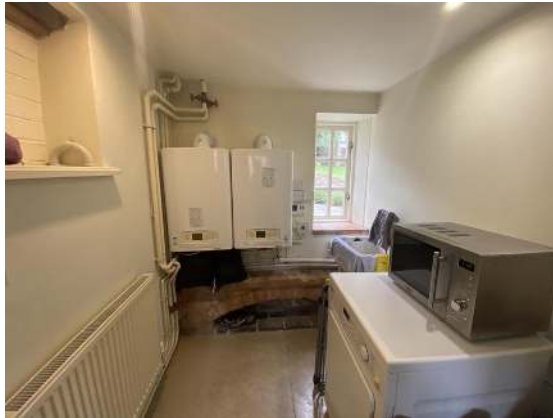
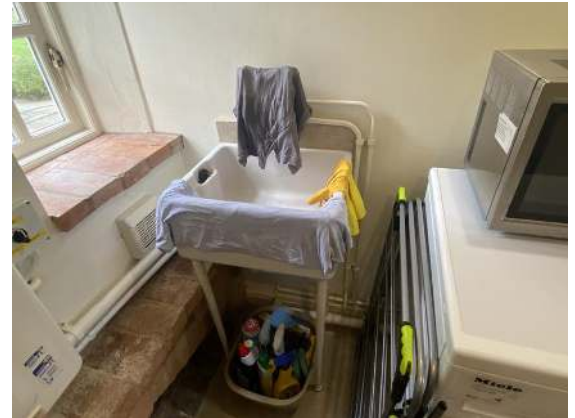
- The fittings generally appear to be in a fair condition. ●

The mastic seals to fittings, particularly worktops, should be renewed regularly to prevent leaks and subsequent damage to the underlying building fabric. Hidden leaks behind fittings can be hard to identify immediately and may go undetected for a prolonged period before visual indications, such as staining or damp, become apparent. We recommend that all seals are monitored and renewed regularly.

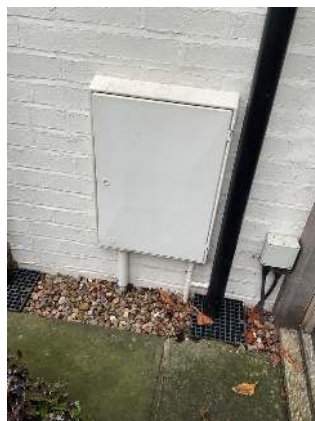
Gas supply

- The gas services appear to be in a fair condition. ●

Whilst the gas services generally appear free from visual defects, we have not undertaken any testing of the gas appliances or services to verify their condition or safety. We recommend your solicitor request copies of any installation, service information and warranties relating to the boiler and associated services.

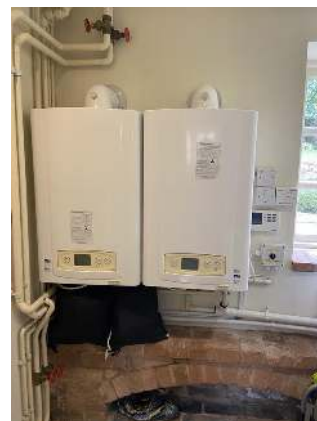
Boilers

- We noted the bathroom, toilet, en-suite bathroom and kitchen are provided with any mechanical extraction to reduce moisture levels to this area. The extractor installation appears to be in a fair condition and in line with current regulations at the time of our inspection, based upon visible elements of the installation. ●
- The heating installation generally appears to be in a fair condition. ●

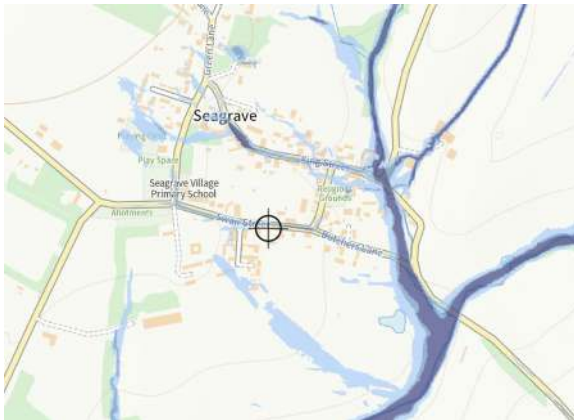
<i>Flood map</i>

10.2	Flooding Risk	
(i)	The records from the Flood Warning Information Service shows the following: <ul style="list-style-type: none"> • Flood risk from surface water - Medium • Flood risk from rivers or sea - Very low • Flood risk from reservoirs - No risk identified 	
(ii)

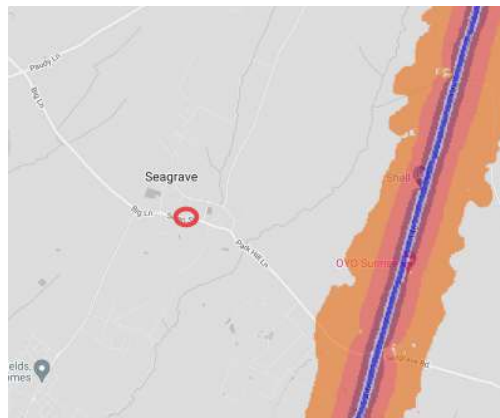
Noise map

Based on the location, the property may be susceptible to disturbance from nearby roads.

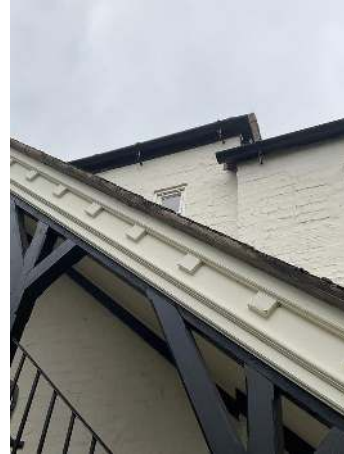
32. Timber fascia

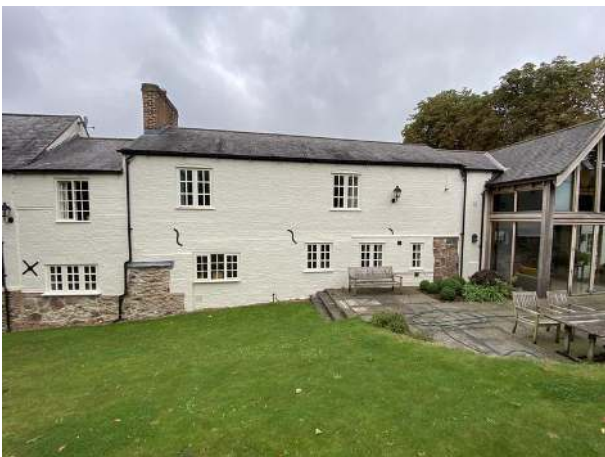
41. Rear patio

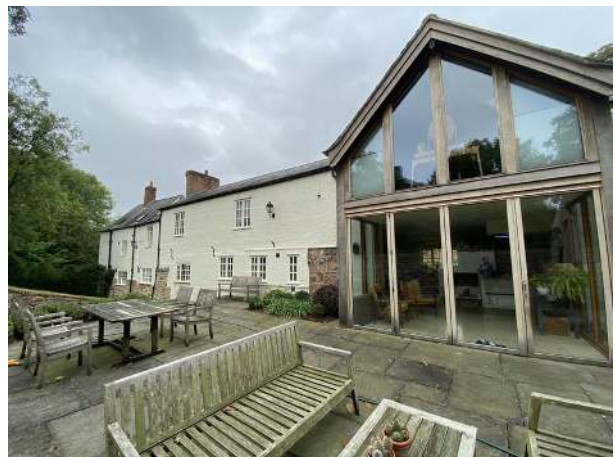
42. Rear patio

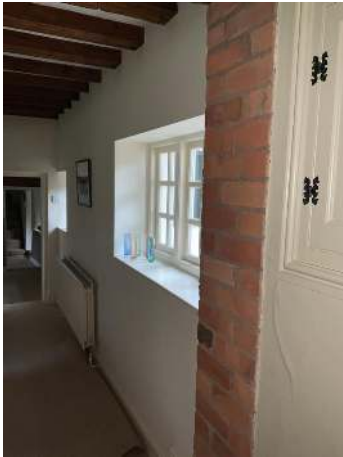
69. Internal walls

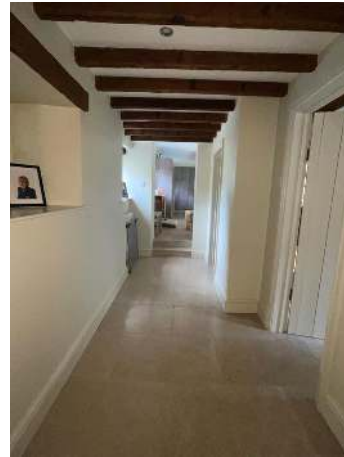
70. Internal walls

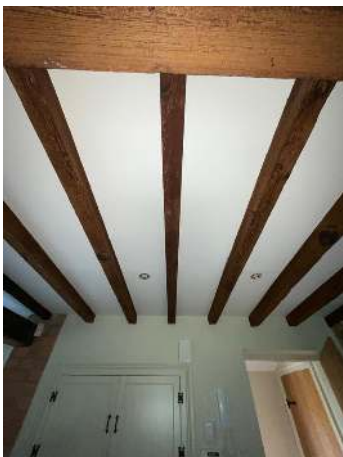
71. Ceilings

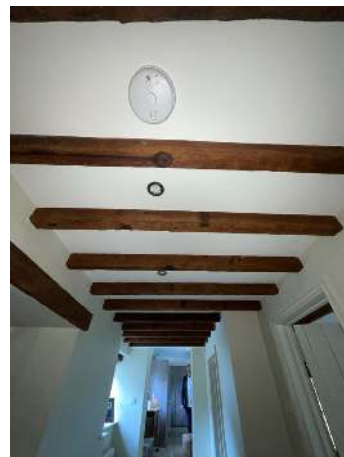
72. Ceilings

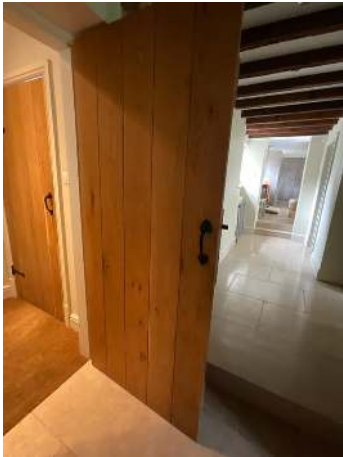
75. Internal door
